Atti del 3° Simposio Internazionale
Proceedings of the 3rd International Symposium
Venezia 1994

La conservazione dei monumenti nel bacino del Mediterraneo

Conservation studies in weathered sandstone from the romanesque façade of the Church of San Julian (Salamanca, Spain)

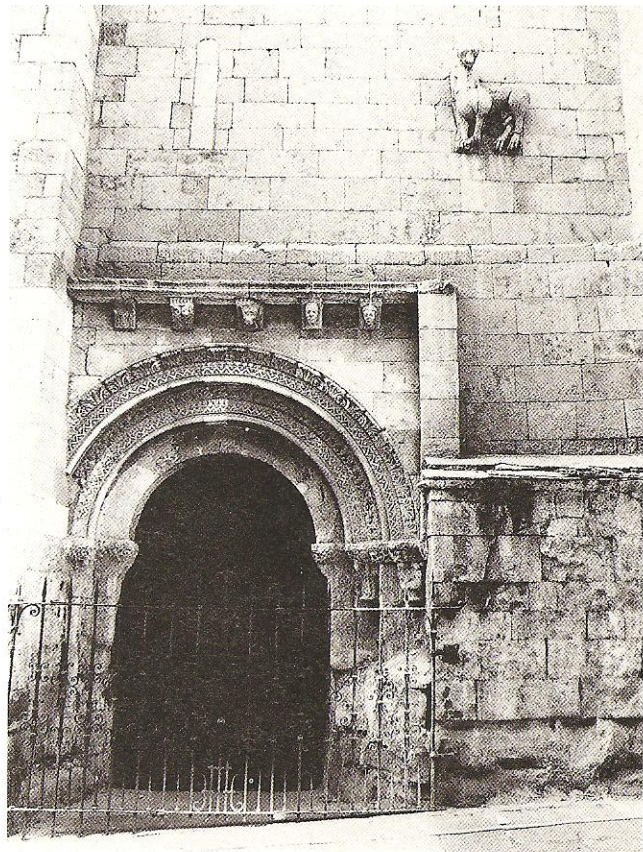
Plate 1. - The Romanesque façade is heavily weathered, the lower parts of the buildings are arenized and many of the decorative components are broken.

The Romanesque façade is heavily weathered (plate 1), the lower parts of the buildings are arenized and many of the decorative components are broken.

The heavy weathering observed in the present case is mainly due to humidity because of damping capillarity with water containing a high level of ions, thus giving rise to salt precipitation upon water evaporation. In addition, the high porosity of the stone favours the penetration of fluids, and the presence of plastic and swelling clays gives rise to slabs formation and arenization, as the two main degradation processes of Villamayor sandstone (Vicente et al., 1986). Humidity may also originate from leaking roofs.

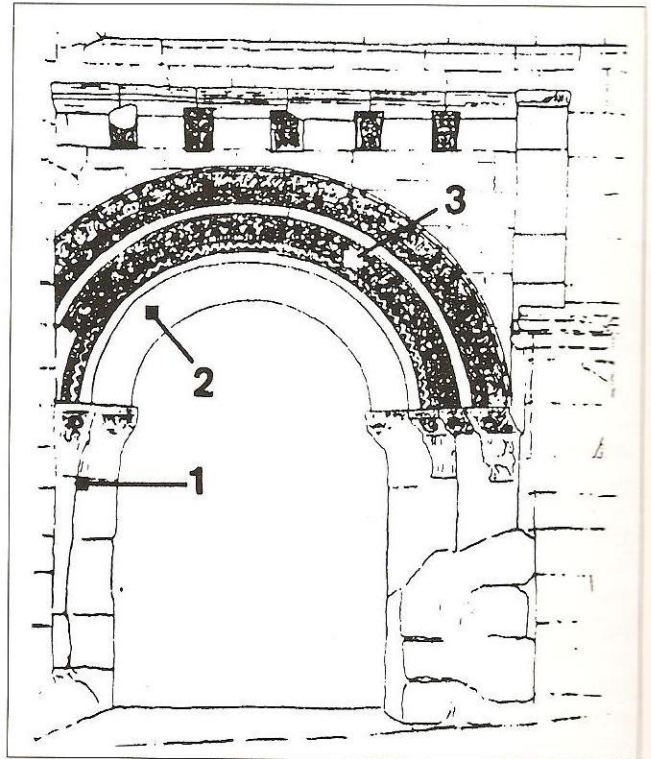
- Zone 1.* Ashlar in the side column of the façade (1). The mineralogical components are quartz, calcite-dolomite, palygorskite, smectite, feldspars, mica and small amounts of gypsum.
- Zone 2.* Black film in the unworked part of the Romanesque façade, just above the door (2). It's black, 2 mm thick, and easily peeled off. The internal side is almost white, and consists of quartz, feldspars, clay minerals (smectite) and iron oxides (goethite), while the external side is black and, in addition to quartz, gypsum and calcite-dolomite, it contains appreciable amounts of salts, mainly sodium, magnesium and potassium salts.
- Zone 3.* Worked part of the arch in the Romanesque façade (3), heavily weathered. The composition

Fig. 1.- The Romanesque façade. Location of sampled zones.

is rather similar to those of samples from zone 1: quartz, calcite-dolomite, palygorskite, smectite, feldspars, mica and gypsum.

Zone 4. Lightly weathered parts of the façade. Once the surface patina is removed, the composition of the remaining stone is quartz, calcite-dolomite, palygorskite, smectite, feldspars and mica.

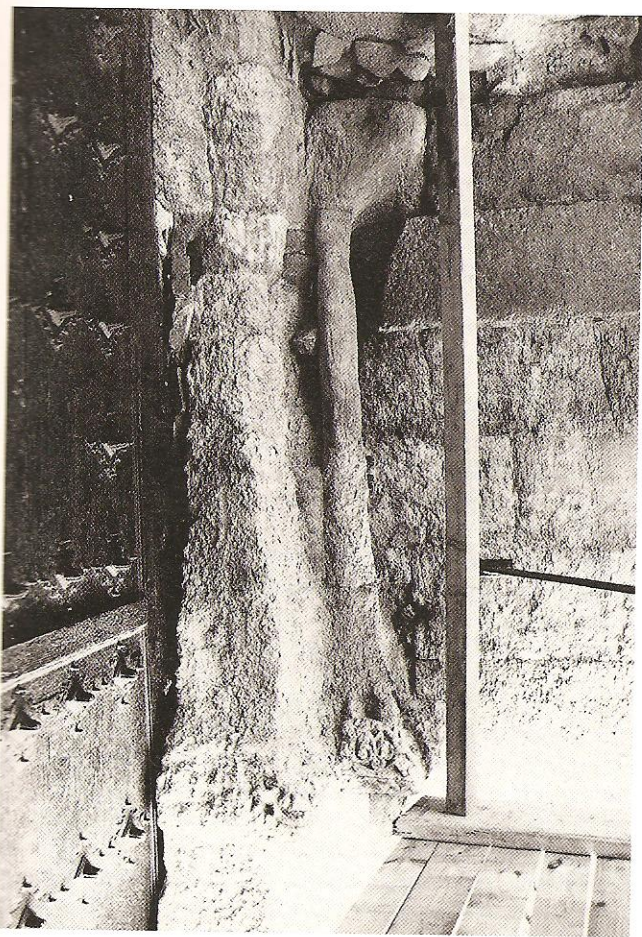
Plate 2.-Unworked ashlar of highly weathered jambs.

In a first step, the surface of the stone has been washed and restored in order to avoid filtration and water accumulation. Unworked ashlar of highly weathered jambs have been substituted (plates 2 and 3). Consolidation studies have been carried out on removed, altered ashlar in order to gain knowledge of the response of the material before performing such a consolidating treatment on the building itself.

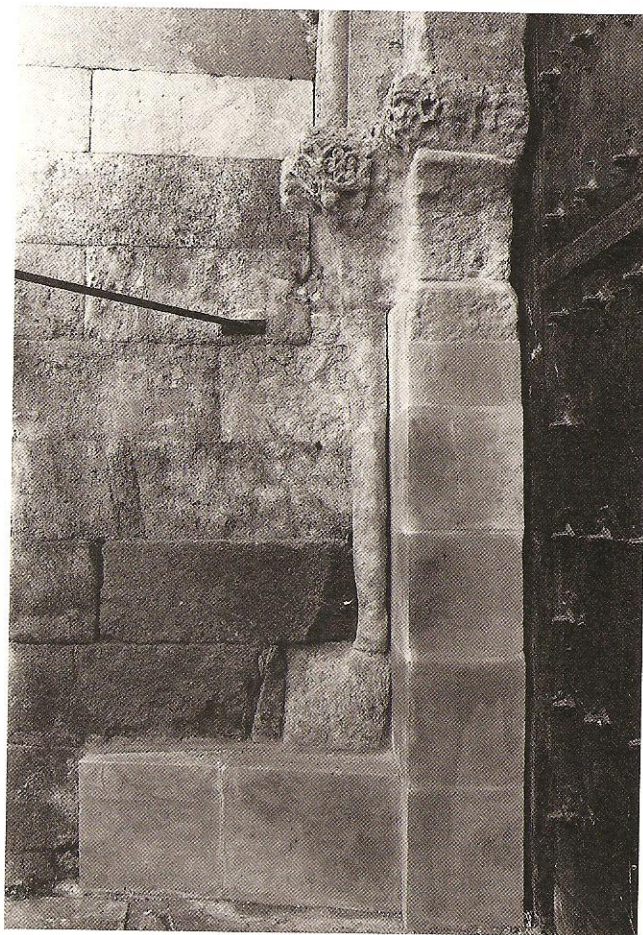
Plate 3.-Substituted ashlar.
