Preliminary investigation of the preparation of repair mortars for the Temple of Diana, Mérida, Spain

Duygu Ergenç, Rafael Fort González

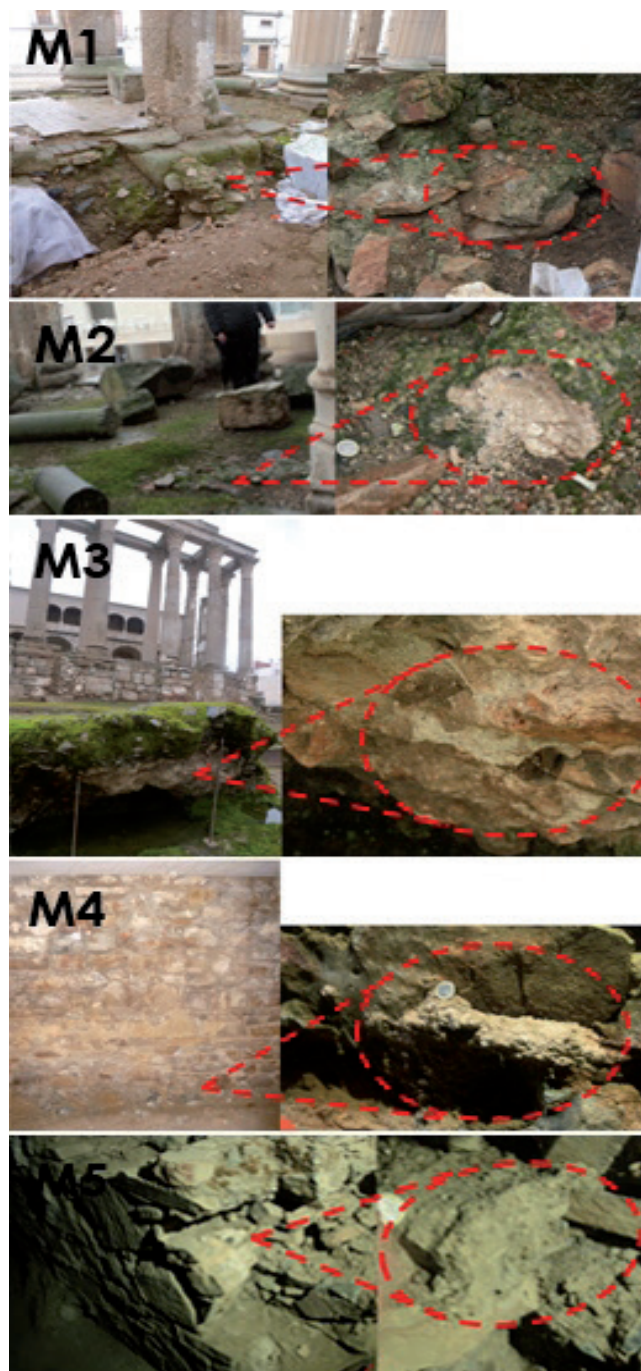
The M1 sample is light brown-beige colour mortar that constitutes 5 mm to 4 cm diameter coarse aggregates (*caementa*) and lime lumps 1-4 cm in size. Poorly sorted aggregates in the porous lime binder are angular to sub-angular, which indicate crushed fragments of the rocks [figure 2]. Sample M2 is a whitish mortar that has coarse 5 mm to 2 cm diameter aggregates (*caementa*). These poorly sorted aggregates are sub-angular to round in shape. The whitish-yellow M3 mortar sample contains 4 mm to 1 cm diameter coarse aggregates (*caementa*), and 1.5 – 4 cm lime lumps. Poorly sorted aggregates in the porous lime binder have angular to sub-angular forms. Sample M4 is whitish in colour and contains smaller, (0.5 to 5 mm diameter) aggregates. Moderately sorted aggregates in the porous lime binder have angular to sub-angular forms, indicating crushed rocks. Sample M5 is whitish-beige mortar with smaller aggregates (0.5 to 5 mm in diameter) and 2 cm lime lumps. Moderately sorted aggregates in the porous lime binder have angular to rounded forms. Although no ceramic fragments were visible to the naked eye, lime lumps were observed in the samples M1, M3, and M5.

Figure 3.- Photos of collected samples with their location in the temple M1: Foundation of the granite ashlar, M2: Flooring, M3: Vault of fountain or channel in front of the temple, M4: Masonry wall of Criptoporticus, M5: Inner wall in Criptoporticus.

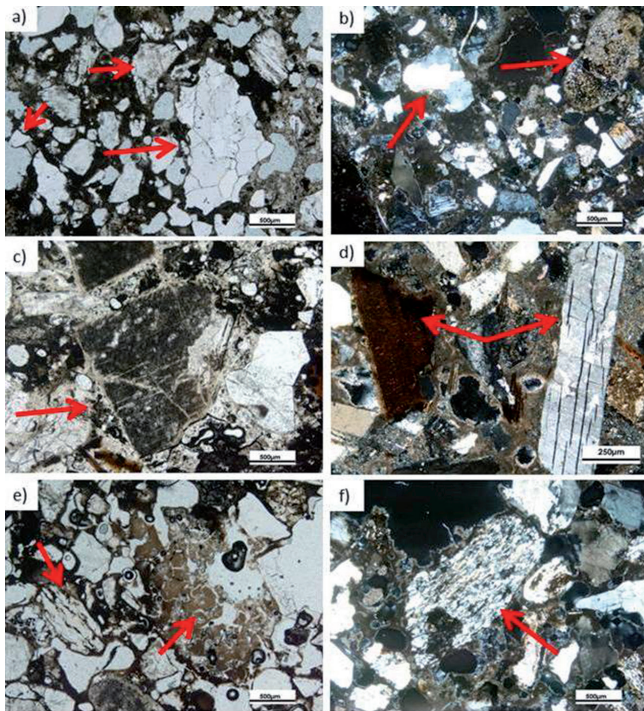
Microphotographs show the aggregates of quartz, calcite, feldspar, biotite, and rock fragments encased in a cryptocrystalline micritic matrix, that indicates use of a lime binder. Except for sample M3, all other observed mortar binders show dark-brown colour and carbonated appearance under the microscope. Granitic rocks, quartzite, slate and schist comprise the observed rock fragments [figure 3], which coincides with the geology of the surroundings (Robador and Arroyo 2013; Mota López 2015). Regarding the fragments; sample M1 contains polycrystalline quartzitic rock fragments, sample M2 has elongated metamorphic rock fragments with rounded edges and rounded opaque minerals, samples M3 and M4 has bigger edged feldspar grains, granitic rocks, and elongated schist, slate and limestone were observed in sample M5 [figure 3].

According to visual examination of thin sections, binder aggregate ratios are estimated 1:4 in M1, M2 and M5 and 1:3 in M3 and M4. 1 to 3 cm lime lumps are encountered only in the samples M1, M3 and M5. Presence of lumps either indicates dry slaking, lack of water in slaking, or poor workmanship (Silva et al. 2006; Moropoulou et al. 2016).

Figure 4. - a) Quartz and feldspar grains together with quartzite fragment embedded in carbonated lime binder in M1 under plane polarized light b) dark brown coloured lime binder with rounded to angular metamorphic rock fragments and quartz and feldspar grains in M2 under cross polarized light c) square edged altered feldspar in M3 under plane polarized light d) Biotite on the left and fragmented plagioclase on the right in M4 under cross polarized light e) Lime lump with recrystallization in its cracks in M5 under plane polarized light f) Schist fragment, quartz feldspar aggregates and large pores in M5 under crossed polarized light.

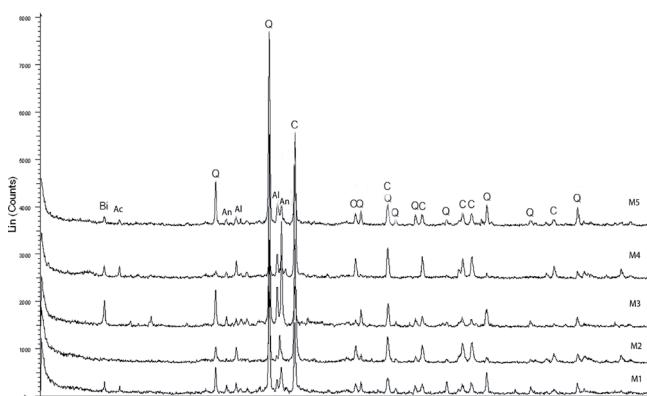
The mineral compositions of mortar samples determined by X-ray diffraction is presented in figure 4. Diffractograms of the samples show that the main constituents of the mortars are quartz, calcite, and feldspar (albite, anorthite). Biotite is the accessory mineral, which is omnipresent in all samples except M2, and is present in greater intensity in sample M3. Proportions of calcite and quartz vary in every sample: in M1, M3 and M5 quartz is predominant, while M4 has very a little amount of quartz. M1, M4 and M5 have the same peaks of actinolite (Ergenc and Fort, in press).

Results of X-ray diffraction analysis supports the petrographic analysis under polarized optical microscopy. In the XRD patterns, calcite, coming from the binder and quartz, feldspar, biotite and actinolite are released due to the granitic and metamorphic rocks that were used as aggregate.

Figure 5. - XRD Patterns of mortar samples of Temple of Diana (Q: quartz, C: calcite, Al: albite, An: anorthite, Bi: biotite, Ac: actinolite).

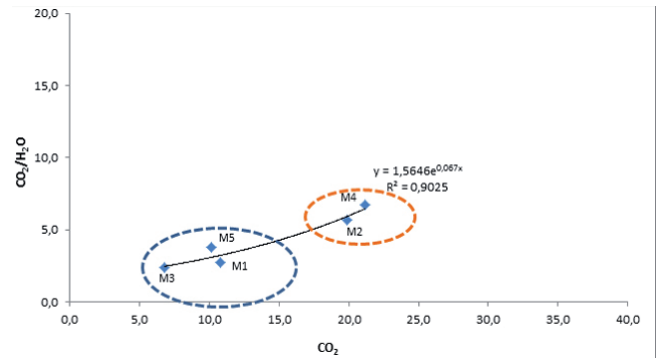
Figure 6. - CO₂/H₂O vs CO₂ plot.

The hydraulicity of mortars is represented by the inverse relation of decomposition of carbonates (CO₂ - weight loss% above 600°C) to structurally bound water (H₂O - weight loss% between 200°C – 600°C) (Bakolas et al. 1995; Moropoulou et al. 2000; 2016; Biscontin et al. 2002; Böke et al. 2008). Figure 6 shows the exponential increase of inverse hydraulicity with CO₂. This correlation allows classification of mortars according to their hydraulic properties. Since none of the samples show CO₂/H₂O higher than 10 and higher CO₂ values, this demonstrates that all have hydraulic character.

As shown in figure 6, two groups are glittered: the first group includes samples M1, M3 and M5, which are suited to 5 – 15% CO₂ and CO₂/H₂O below 5%, and the second group including samples M2 and M4 fall into the ranges of 15 – 25% CO₂ and 5 – 10% CO₂/H₂O. First group can be classified as highly hydraulic (Bonazza et al. 2013) or natural pozzolanic mortars (Moropoulou et al. 2000; 2005; Genestar et al. 2006). The second group can be classified as hydraulic mortars (Bonazza et al. 2013), or artificial pozzolanic mortars (Moropoulou et al. 2000; 2005; Genestar et al. 2006).
