ASSESSMENT AND EVALUATION OF THE REPAIR OPTIONS FOR THE TORROJA INSTITUTE WINTER GARDEN

O. Río & J Mateo
CSIC-UPM
CISDEM
Serrano Galvache, 4
28033-Madrid
Spain
rio@ietcc.csic.es

KEYWORDS: crack repairs, masonry shell, unreinforced brickwork, Torroja, FE analysis

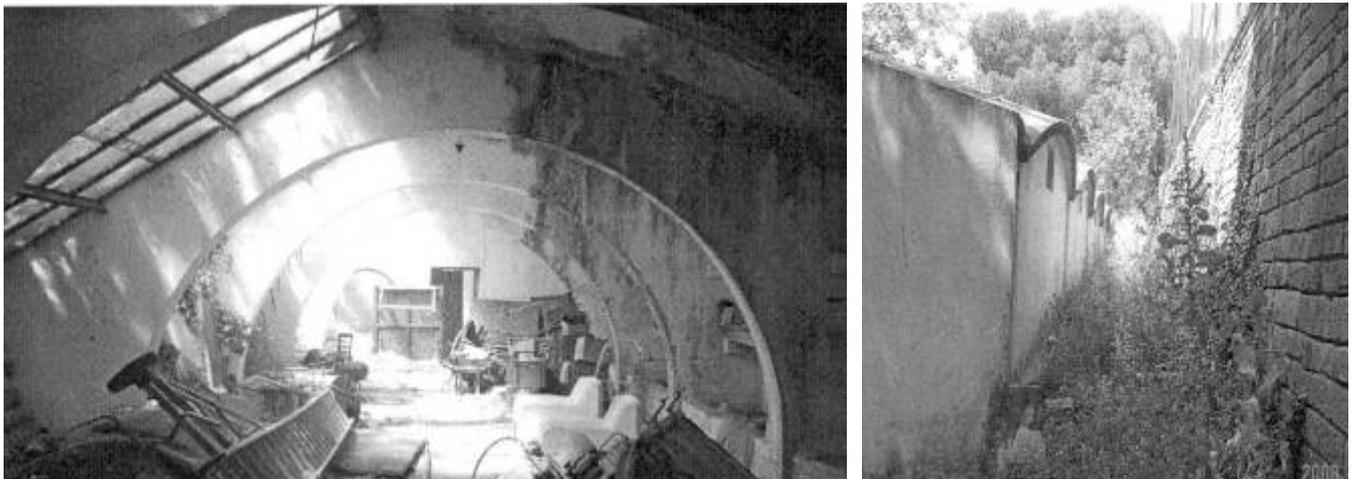
Figure 4: Aspect of the Winter Garden and surrounding area in 2008.

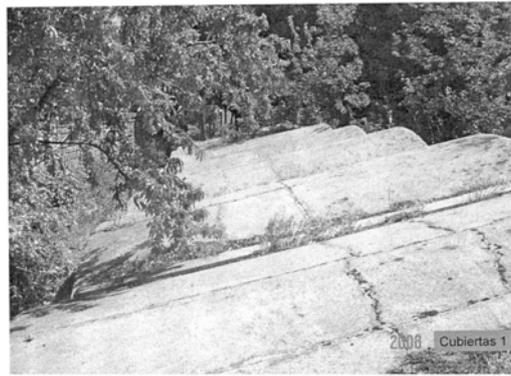
Figure 7: External aspect of the vaults

The degradation of the joints at the vaults led to water ingress to the arches and the weakened bond between the bricks caused cracks on the vaults and hinges at the crown of the arches towards the spandrels and the back side, partially buried in the natural slope. There are some pronounced cracks in the longitudinal axis of the shells (Fig. 9) and spread is prevented probably due to the mutual constraint of the adjacent bays along the arches (Fig. 2) and the diaphragm action at the back. Transverse (hoop) cracks are also apparent, mainly along the bed joints of the brickwork (Fig. 9) but the extrados also shows a series of cracks also closer the longitudinal apex (Fig. 7).

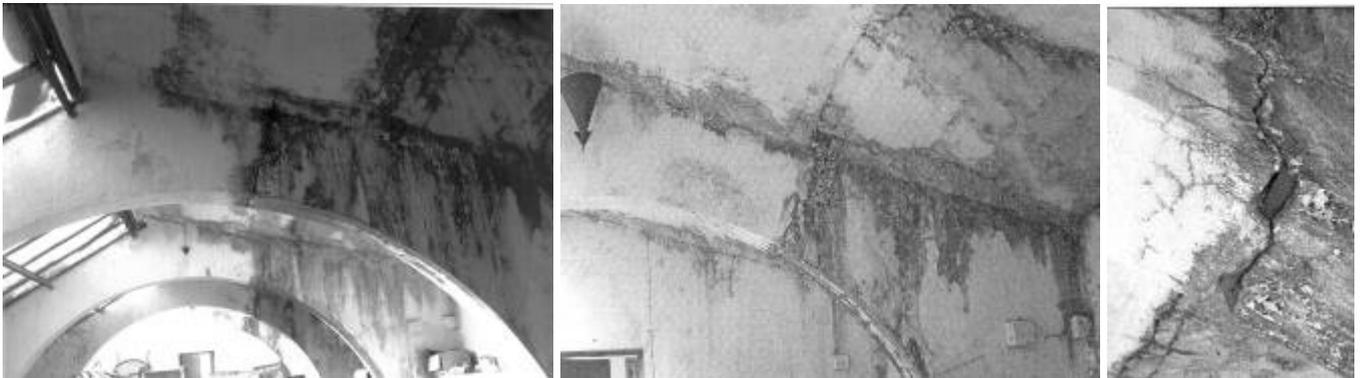
Figure 8. Damages observed on the arches: first or easternmost arch (left), last or westernmost arch (middle), detail of the main crack in the first arch (right).

Regarding the masonry arches, they present a main crack that runs in general through the whole cross-section off the keystone towards the north wall and other smaller ones in the area in between. Although they appear in all the arches, their size and especially width is decreasing towards the west end (Fig. 8). Similarly, the extent of the damage due to moisture penetration decreases when moving from east to west.

As far as the deformation of the arches is concerned, the asymmetric crack pattern is due to the higher weight of the vault (at the N side in Figs. 4 and 8) and the water ingress that has caused the decay of the mortar joints next to the spandrels. There may also be more complex interactions between the arches and the vaults and a more detailed analysis of the behaviour is carried in the next section in order to get more insight to the distribution of the loads.

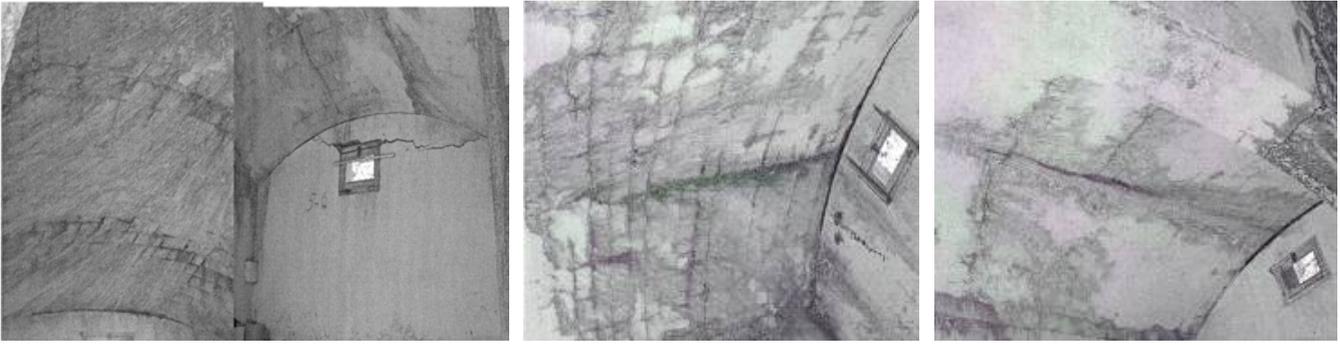
So far as the roof barrel vaults are concerned, they present cracks along the east-west axis mainly on the north half of the vault (Fig. 9) as also perpendicular cracks located next to the arch elements (Fig. 8) and along the main axis of the vault. Similar to the arch damages, their size decrease towards the west end of the building. Moisture damage follows the crack pattern but does not decrease so much, and is greater on the middle vault, being more pronounced as cracks at the mortar joints.

Figure 9: Damages on the vaults and their N wall end. From left to right bays 1, 2, 3 and 5 (Oteiza 2008)

The structure sits also on the slope so differential movement could have destabilised the containment of the bays in the longitudinal direction, as also the changes in the crack pattern show (Fig. 9). Settlement could have also increased the deformation around the windows of the wall in bay 2 (Fig. 9), which could have originated from the detachment of the vault from the wall (S11 in Fig. 13).

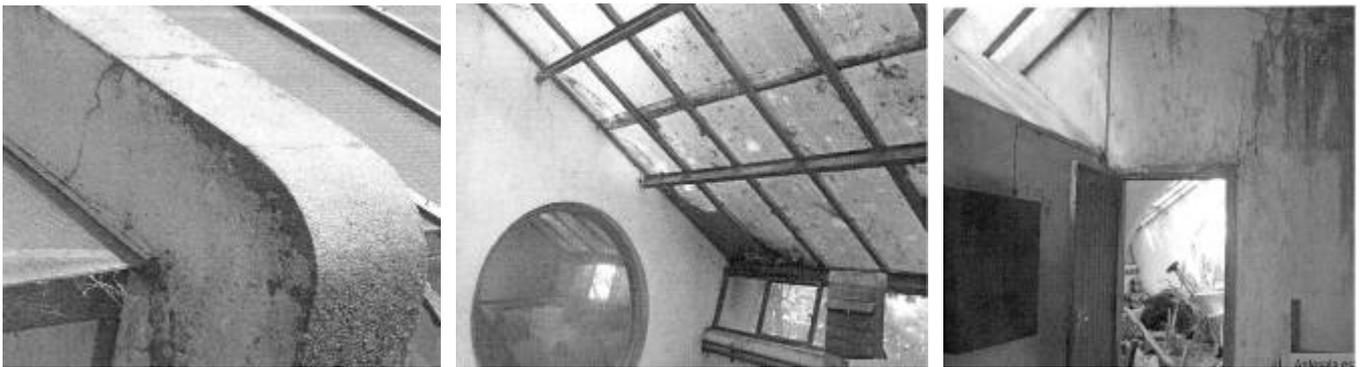
No significant damages were observed on the structural elements near the windows with the exception of those where the south wall joined the glazing (Fig. 10). A large number of glass panels were broken; the steel structure had deteriorated and water tightness sealant was nonexistent. The doors and window frames of the north wall also showed damage signs.

Figure 10. Other damages: main arches, window structure, interior of the east end

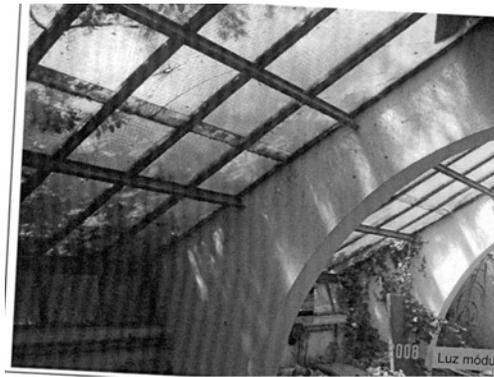
The small size of the building and the modest loads that were expected to act did not require a demanding structural scheme. Due to the orientation of the building, the temperature variations on the steel frame that holds the glazing could have caused significant expansion, which would need to be accommodated or isolated from the arches and vaults. The vaults shed their weight and thrust on the transverse arches/ ribs and they are also supported upon a wall at their back (North) end (Figs. 4 and 11). Most probably the structure was empirically sized by Torroja and he would rely upon experienced bricklayers who still had the knowledge of building arches and shallow vaults, as the techniques were widely used in Madrid until the 1960's (Moya 1993).

Figure 11: The attachment of the mullions on the arches at bay 1

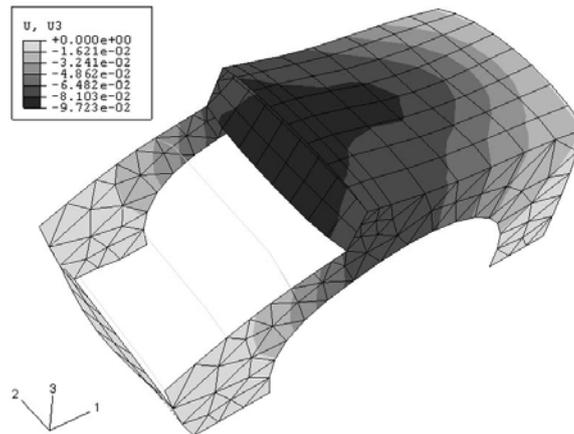
The analysis shows the high reserves in strength of the form under the ideal conditions considered here. The deformation of the model in Fig. 12 shows a higher concentration of vertical displacement at the inner end of the vault, above the lintel of the window, but the values are overall small, to a maximum of 0.1 mm. A study of the distribution of the stresses at the extrados of the vault (Fig. 13) shows the middle strip of the vault cantilevers towards the window (axial tensile stresses S11 at both ends), while in the hoop direction (S22) the tensile forces appear along the edge with the arches. The latter tensile forces are higher along those edges and this is where the cracks are expected to start if a high load is considered to act. The overall values however are small (maximum 130 kN/m² or 0.13 N/mm² in the hoop direction), while max compressive stresses are about 0.3 N/mm², i.e. well below the assumed strength.

Figure 12. Deformation and deflections of the FE model for bay 3 (in mm)

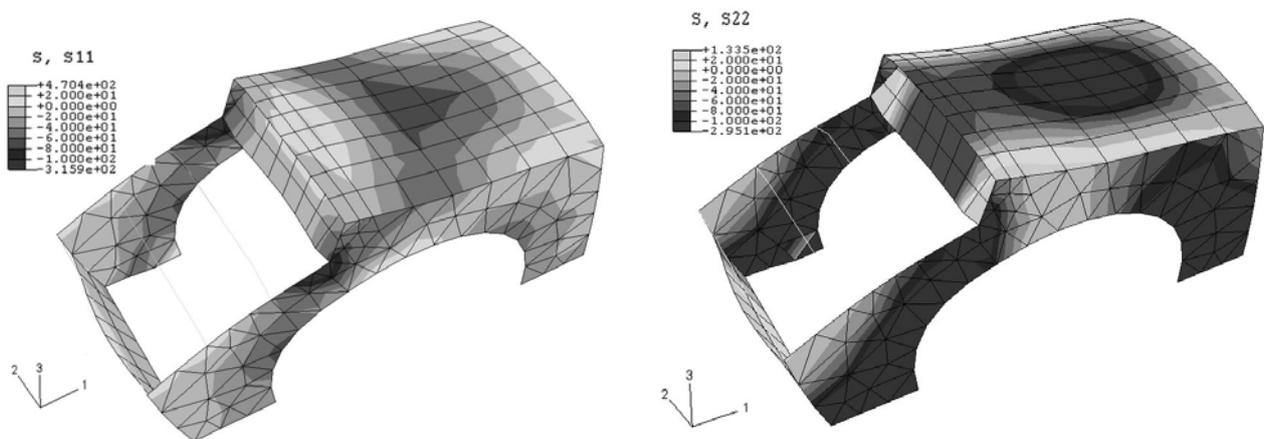
Figure 13: Loads at the extrados of the vaults in bay 3 in the axial (S11) and hoop direction (S22) in kN/m². Stresses S11 have a radial direction in the case of the arches.

The deformation of the vault spreads further into the arch and the area of the crown deforms relatively higher. The distribution of the radial stresses (S11 in Fig. 13) shows higher tensile forces in an area that coincides with the location of the main cracks, as they appear in Figs. 4 and 8, therefore it is reasonable to justify the damage observed.

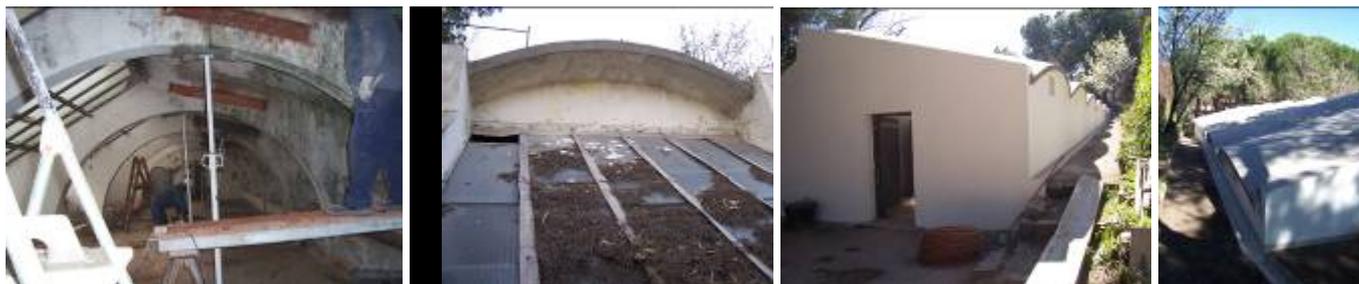
Figure 14: Different stages of repairing and cleaning of the building and the surrounding area.

The understanding of the crack pattern and the dynamics of deformation permitted the planning of the strengthening works in the essential areas, as part of the rehabilitation of the building. At the start of the works, the entire brickwork was essentially stripped down completely from the render and this allowed the crack pattern to be better surveyed. Then, all the mortar joints were cleared in order to ensure that all degraded material was removed. All minor cracks were filled and the joints were repointed. The major structural repair was to stitch the main crack in each arch using a metal plate in the direction that the hinge is expected to open (Fig. 14).
