PROCEEDINGS OF THE FIRST INTERNATIONAL CONFERENCE ON RAMMED EARTH
CONSERVATION, RESTAPIA 2012, VALENCIA, SPAIN, 21–23 JUNE 2012

Rammed Earth Conservation

Restoration of the Andalusí wall of the Alcazaba Antigua (Ancient Citadel) of Granada (Cuesta de Alhacaba area)

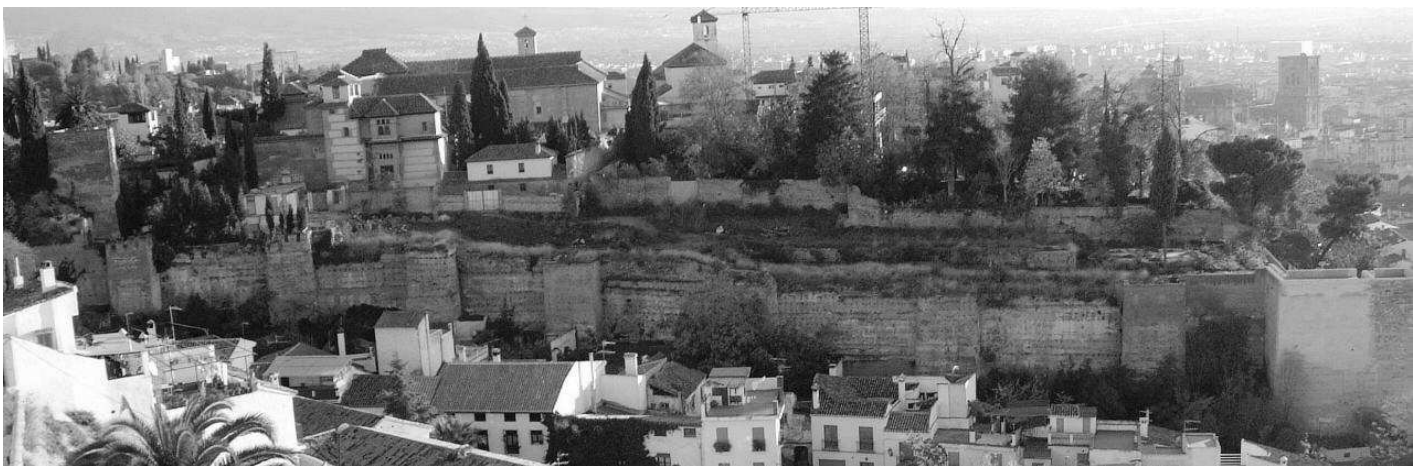
Figure 1. View of the western section before the restoration.

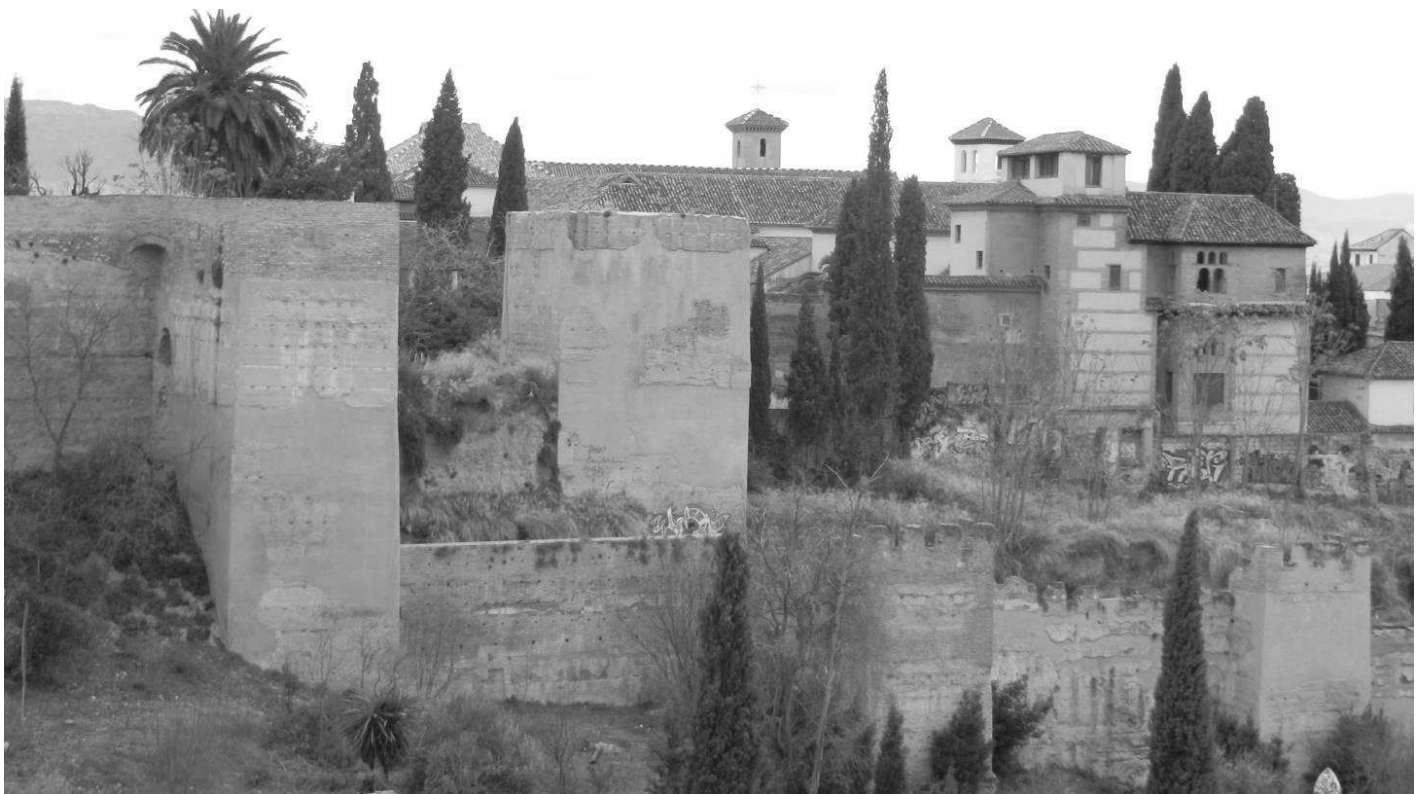
Figure 4. View of the central section after the restoration.

The small *agujas* holes that had grown larger due to the action of groups of animals, as mentioned previously, were filled up sufficiently to hinder them nesting, but not completely, to avoid any radical change in the previous image of the wall. Nevertheless, the large anthropic cavities in the wall faces were totally blocked up. The caves excavated under some panels were also filled in using heavy stone lime concrete (Figs. 4-6).

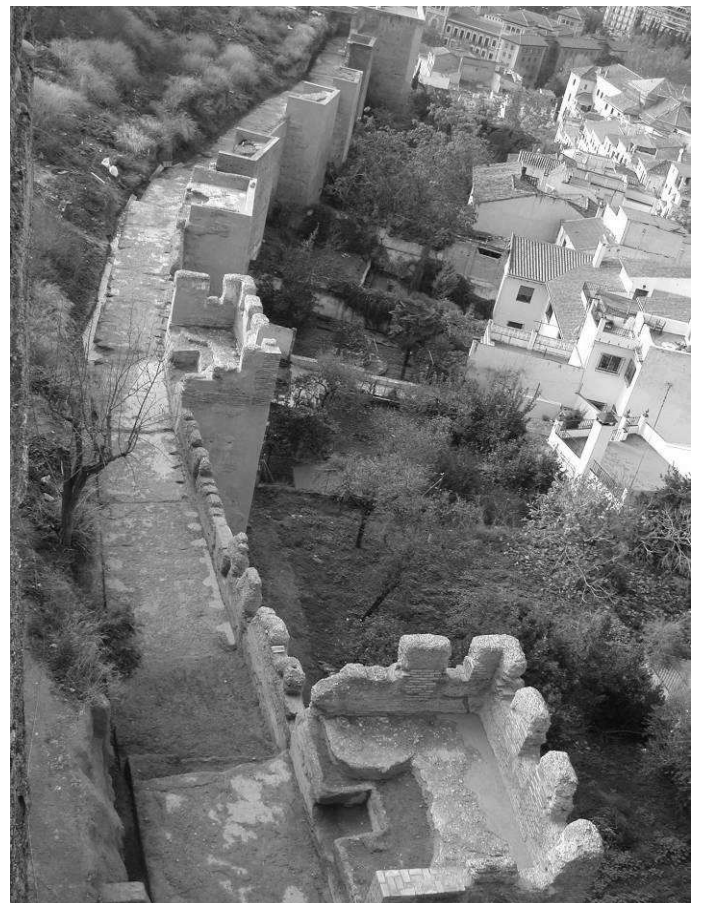
Figure 6. View from tower 8 to tower 14 after the restoration.

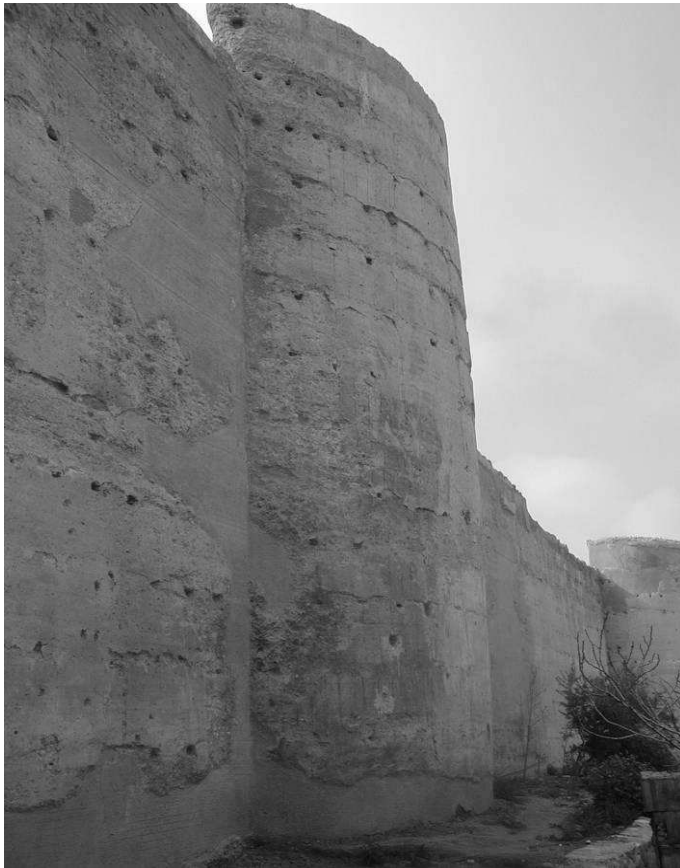
Figure 7. View of towers 2 and 3 after the restoration.

It was important that the thickness of the coats of reintegration mortar was not more than 1 cm, since due to the characteristics of this material a greater thickness would mean its cracking and becoming detached because of lacking sufficient air for carbonization. These coats were laid by throwing them gate would stick on to it. The edge of each of the coats

was gate would stick on to it. The edge of each of the coats was well closed on top of the previous one and on the base of the material (Fig. 7).

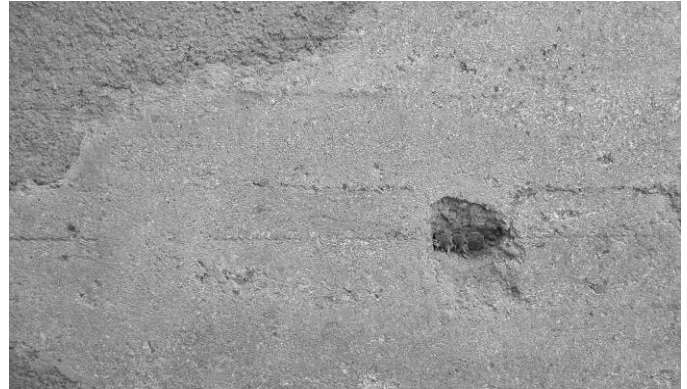
two courses of *tapias* above the panels and they can be reached from the parapet walk by very high steps, shuttered in the *tapias* of the towers. They were built by means of greyish *tapias calicostradas* (rammed earth with a hard lime crusted surface) with courses of 71-84 cm in height. They had *agujas* (pieces of wood for sustaining the shuttering) of boards of 8 x 2.5 cm that were set inside, except in the parapets, where they could be retrieved. In almost all the towers and panels we can see various impressions left by the esparto grass rope on the surface of the wall, and situated horizontally at the height of the *agujas*. Possibly these ropes were used to control the horizontal level of the construction, as they utilized several plank moulds at the same time (Fig. 8).

Figure 8. Detail of *aguja* and esparto grass trace on the *tapia*.
