## URBAN GEOMONUMENTAL ROUTE FOCUSING ON THE PETROLOGICAL AND DECAY FEATURES FOUND IN TRADITIONAL BUILDING STONES USED IN MADRID, SPAIN --Manuscript Draft--

**URBAN GEOMONUMENTAL ROUTE FOCUSING ON THE PETROLOGICAL AND DECAY  
FEATURES FOUND IN TRADITIONAL BUILDING STONES USED IN MADRID, SPAIN**

## 18 **2. GEOMONUMENTAL URBAN ROUTE: PETROLOGICAL AND DECAY FEATURES** 19 **IN TRADITIONAL BUILDING STONES USED ON MADRID'S ROYAL PALACE** 20

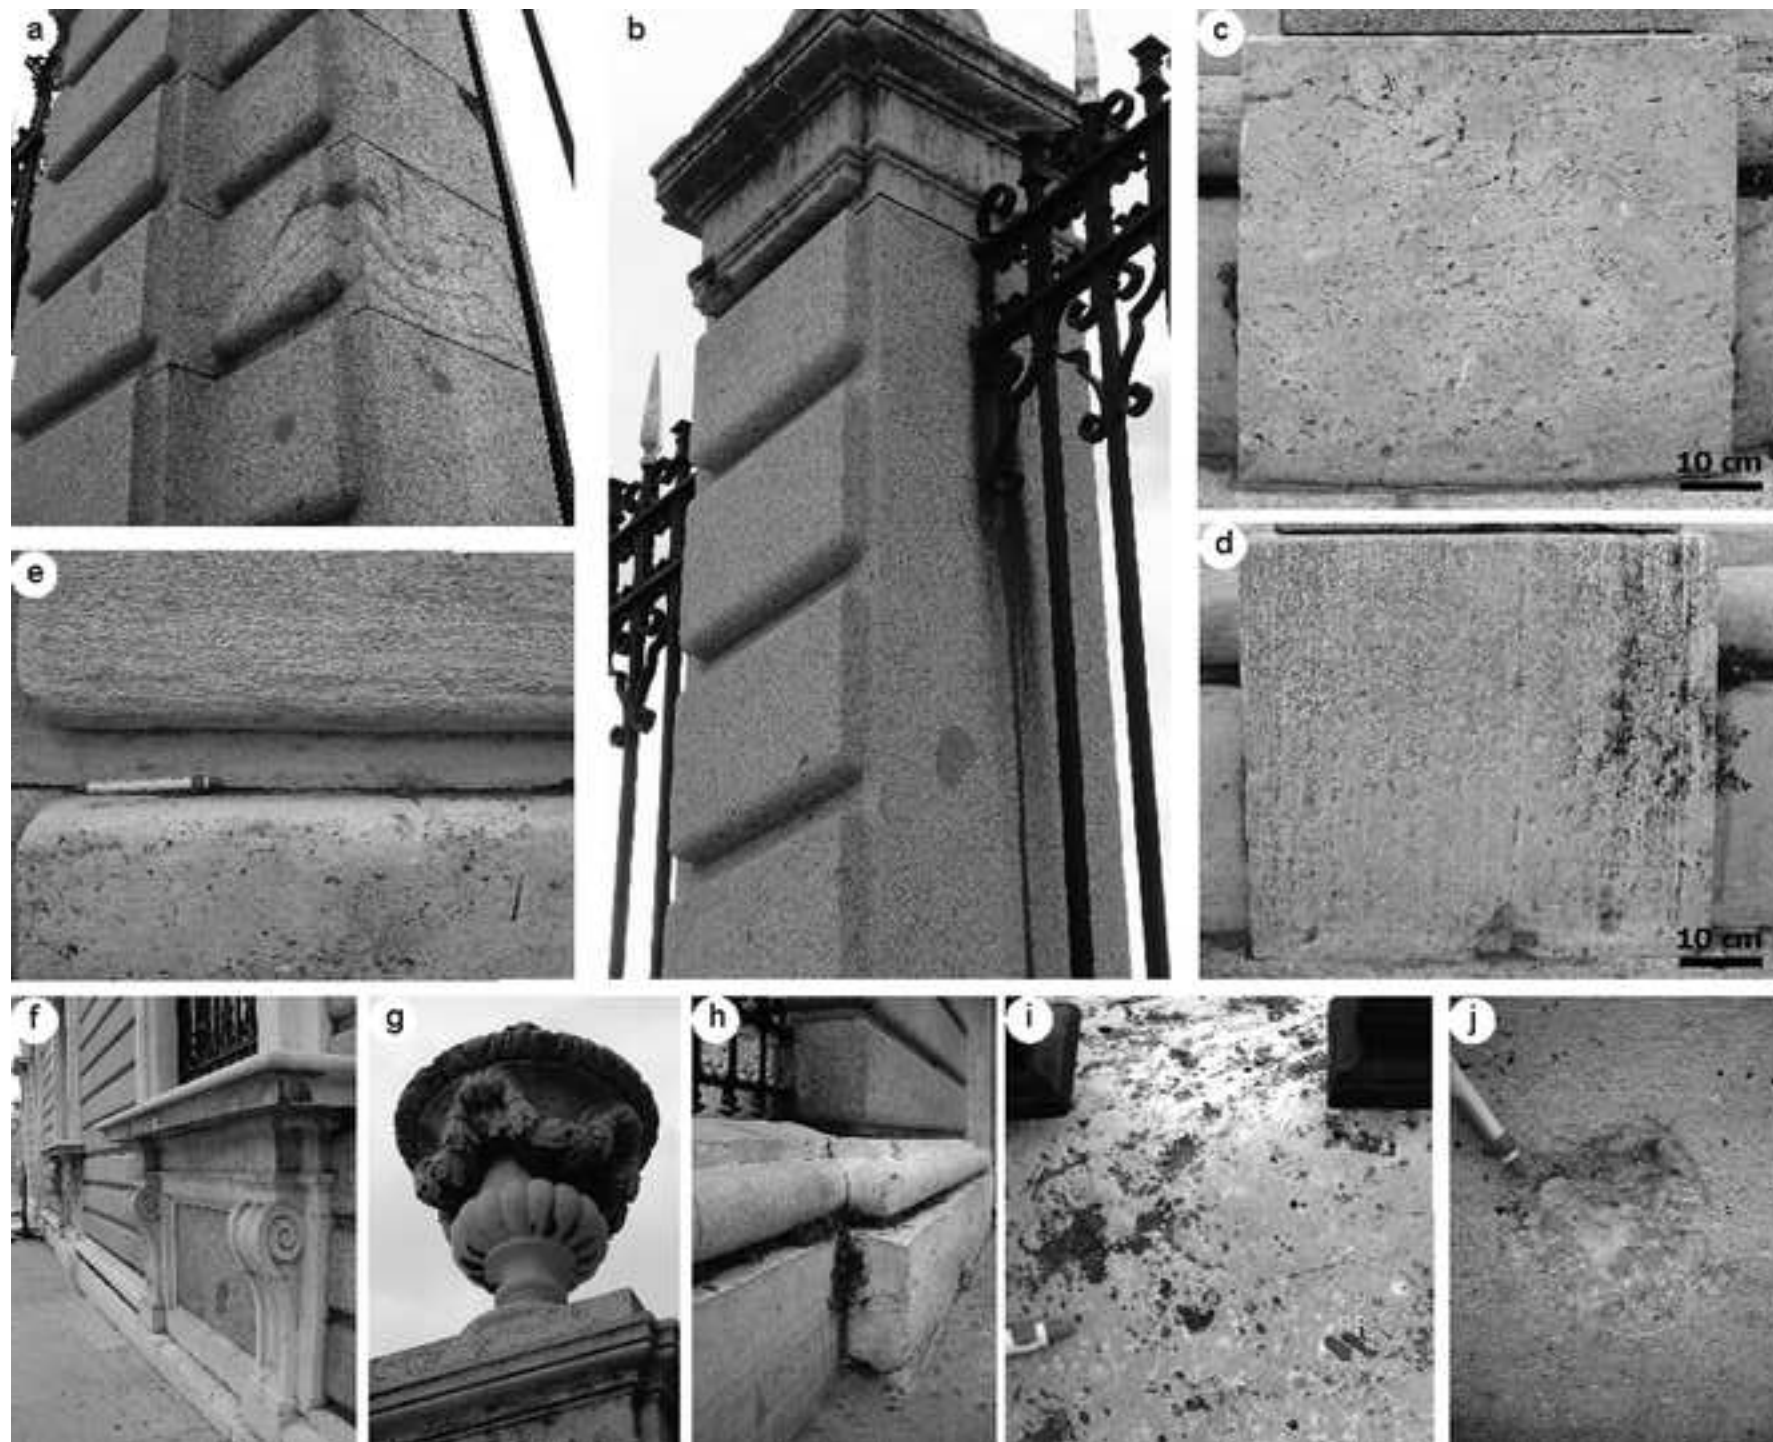
Occasional streaks known as *schlieren* can be seen in the *berroqueña stone* (Figure 6a). These dark streaks, consisting majorly of biotites, were formed in the rock when enclaves were elongated by a molten flow (Barrière 1981; Weinberg et al. 2001). The constructive elements include columns consisting of several ashlar (Figure 6a) or a single block (Figure 6b), and ashlar cushioned either on all their visible surfaces or only on the side facing Almudena Cathedral (Figures 6a and 6b). The surface stains on stone due to the rusting of the iron elements (Figure 6b) constitute a type of decay not observed in the previous stops. Fort et al. (2004b) studied the iron elements used to join and anchor the stone and reported that their expansion as a result of water entry induces cracking in the stone support where they are set.

This second type of limestone may have been the same used to replace the original on the west façade, possibly quarried from the bank known as *Sobrebanco* as has already mentioned (Fort et al. 1996). In some cases, the stratification was not positioned perpendicular to the base of the block (Figure 6d) as it should have been to mitigate decay (Fort et al. 2011). Both limestone ashlar at the gate into the Arms Courtyard are cushioned (Figure 6e).

Two further forms of decay that slightly affect building stone can also be seen from this stop: biodeterioration and stone rupture. Biodeterioration includes all the processes of biological origin that affect the built heritage (De los Ríos et al. 2009). Building stones are colonised by lithobiontic communities, a term that covers a wide variety of microorganisms from bacteria, cyanobacteria, algae and free-living fungi, to higher organisms such as lichens, mosses and vascular plants (Ascaso et al. 2002). Vascular plants can be seen to be growing on construction elements (Figure 6h), in the inner zones of stone elements moldings, which are pathways for moisture entrance and/or water accumulation. Lichen growth, sustained by the moisture retained in the pores on horizontal limestone

surfaces, is also visible from this stop (Figure 6i). Finally, the loss of material observed in a few stone elements (Figure 6j) may be the result of anthropic activity. The many impacts seen on the west façade of the palace, not included in the route proposed, are remnants of the Spanish Civil War (1936-1939). This decay form weakens the surrounding stone by favouring the entry and action of decay agents.

*Berroqueña* stone: (a) *Gabarros*, *schlieren* and ashlar cushioning only on the side facing Almudena Cathedral; (b) stains caused by the dissolution of iron elements and column consisting of a single, successively cushioned stone block.
