ANNUAL
of the
DEPARTMENT OF ANTIQUITIES
of JORDAN

EXCAVATION OF BUILDING F OF THE Umayyad PALACE OF AMMAN

PRELIMINARY REPORT

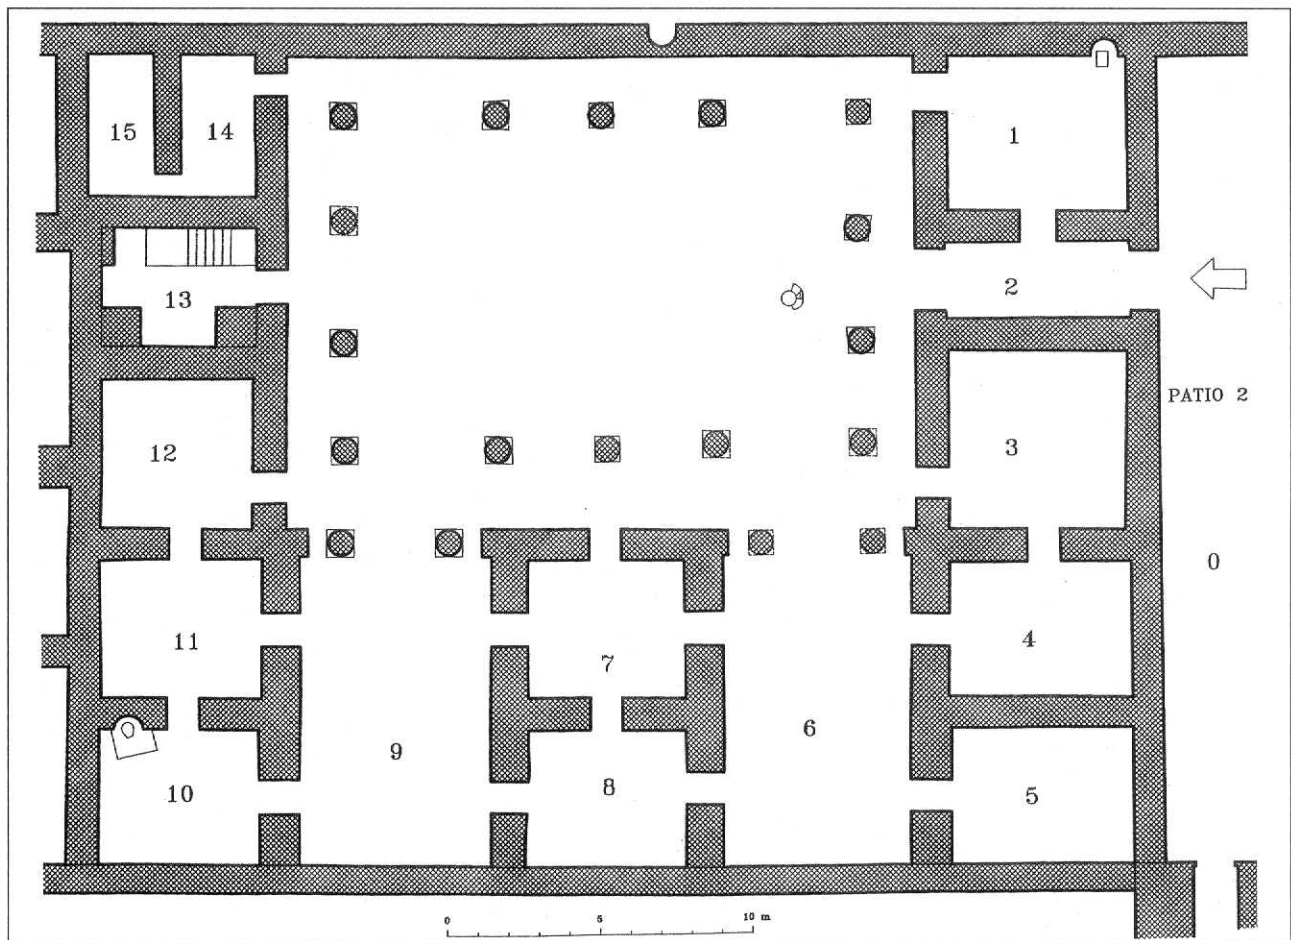
2. Plan of building F.

Building F occupies a rectangular area of 27 m north-south, and 35.90 m east-west (Figs. 2-5). Access to the building is through a doorway, 1.95 m wide giving onto a long space in the shape of a corridor, 2.45 m wide and 5.95 m long. At the opposite end of the corridor, there is a doorway similar to the outside one, communicating with the central courtyard of the building.

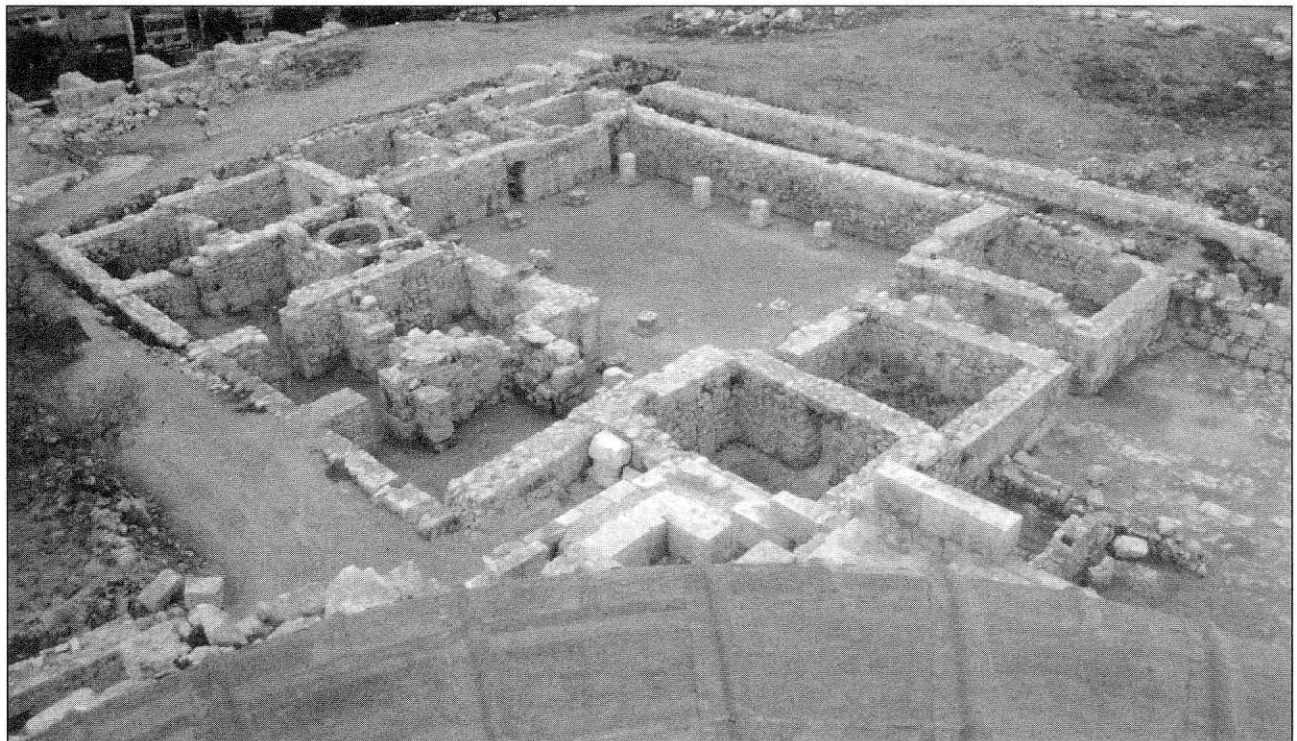
3. Building F from the top of the entrance hall dome.

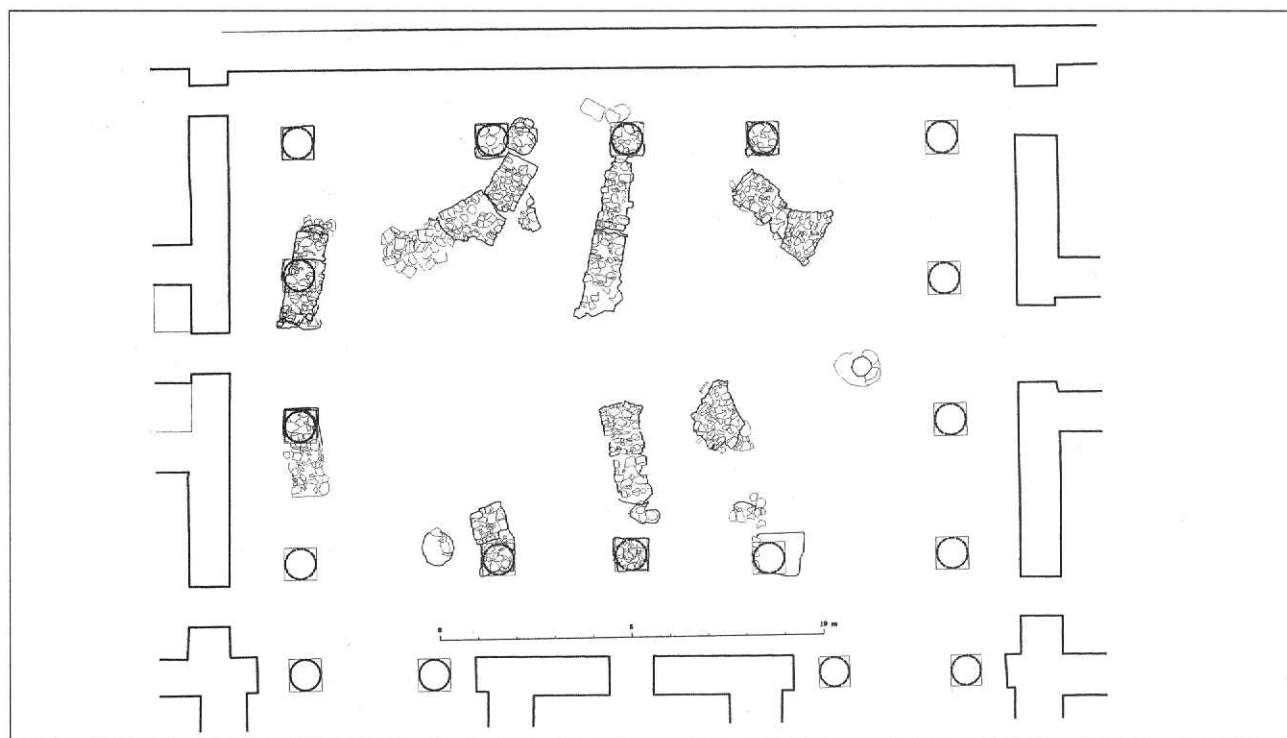
6. Remains of the arches and columns in the courtyard of building F.

The main nucleus of the building consists of a courtyard with porticoes on all four sides measuring 20.50 m from east to west and 15.20 m from north to south (Figs. 6-7). The courtyard is placed towards the north, attached to the outer wall of that side, while on the other three sides it is surrounded by three bays. The porticoes are formed by four arches on the two larger sides and three

Undoubtedly, the most outstanding thing about the columns and arches, both of the porticoes and of the tripartite openings giving on to the *iwāns*, is their building technique and particular shape. The columns, with a plain cylindrical shaft, straight and without entasis and with no decoration, stem from a base composed of a simple plinth, 0.82 m long and 0.20 m high. The shaft, 2.35 m high by 0.80 m in diameter, was crowned by a square horizontal plane, of similar dimensions to the base, and with two arches starting from it. These had an initial vertical stretch, from the plane of the crown of the column to the starting of the arch. At this point there was a small projection from the plane of the surface of the intrados, where the concave part started. This projection could be set at two different heights, to compensate for the different span of the archways and to enable the keystones to be situated at the same height. Both the columns and the arches were built of rough masonry joined with gypsum mortar, probably mixed with some lime.

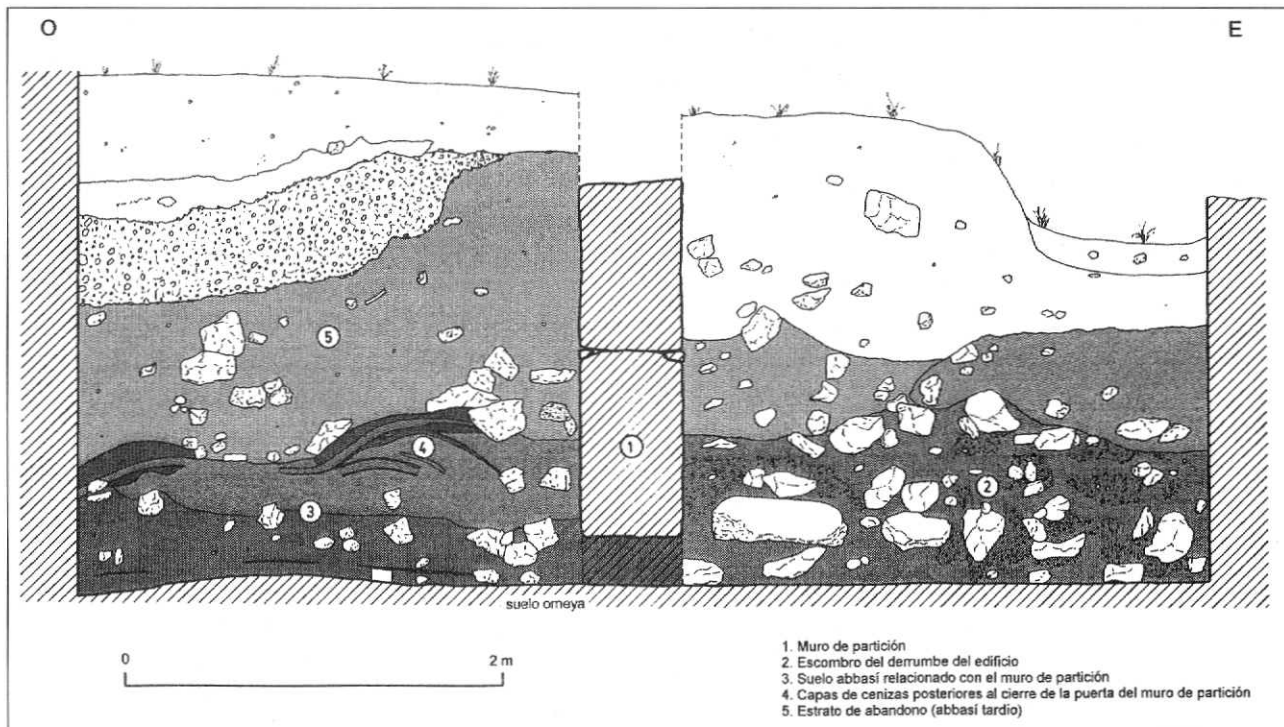
8. Stratigraphy of room 1.

Room n° 1 (Fig. 8), situated at the north end of the eastern bay, is almost square, 4.95 m from north to south by 5.80 m from east to west. It has a doorway in the north east angle, 1.25 m wide giving access from the courtyard. There is a small niche in the eastern end of the north wall which houses the opening of a cistern (Fig. 9).

The earthquake also seems to have been withstood by some rooms which, after the disaster, were partitioned by means of walls which were probably meant to support the roofs: this is the case of rooms 1 (see Fig. 8) and 12. In others, however, the construction of such interior walls must have been accompanied by the reconstruction of roofs. This must have happened, for example, in room n° 3 (see Fig. 10), because the partition wall was founded on top of a stratum of rubble from the Umayyad building.

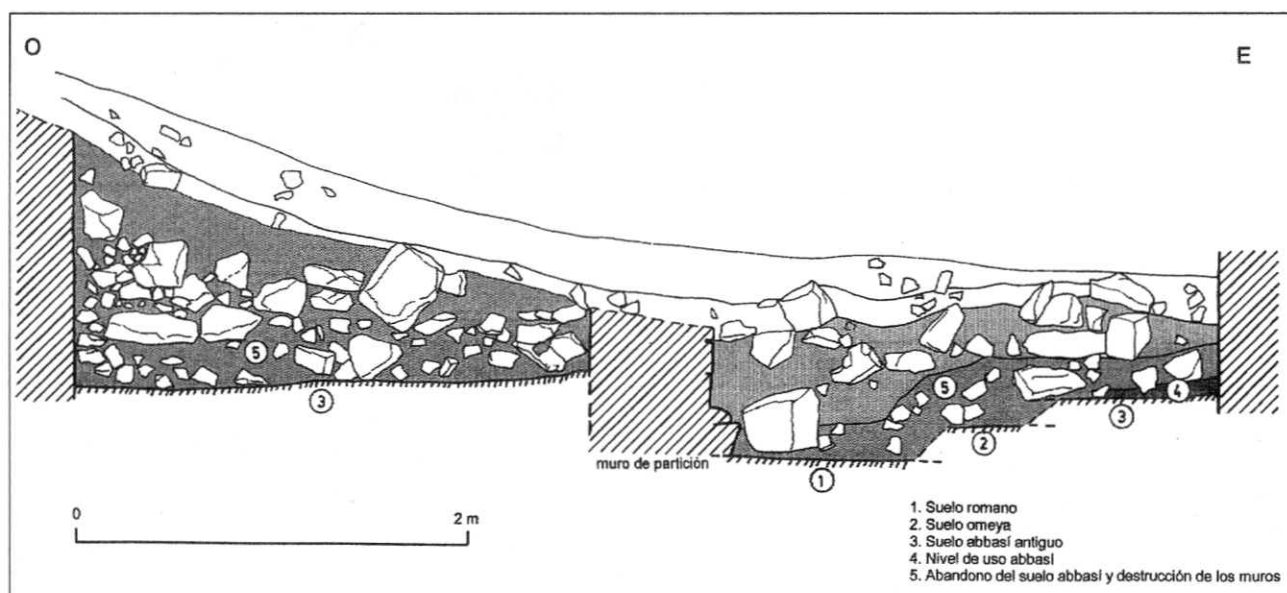
10. Stratigraphy of room 3.

After room n° 1 is the corridor giving access to n° 2, which we have already described. The following room in this space, n° 3 (Fig. 10), is practically 5.80 m², and has communicating doors with the courtyard and the following room which we should now consider part of the southern bay. The door communicating with the courtyard is not centred, but situated in the South-east corner, so as to be in line with the southern portico of the courtyard.

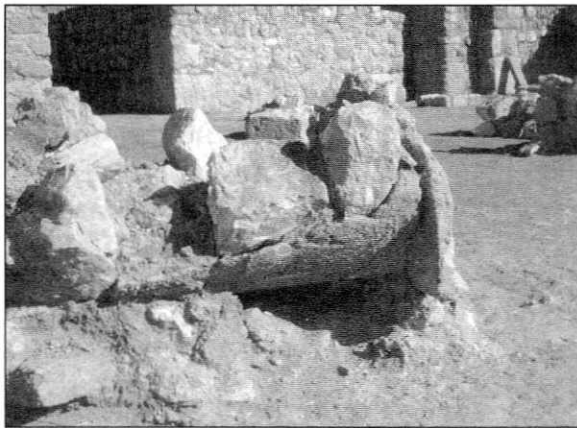
In our opinion, the construction techniques of Persian and Mesopotamian origin are of greater interest. Among these, the most outstanding is the use of gypsum, used in a specific form in certain constructive elements of the palace³. Gypsum appears to have been used in elements requiring an immediate loading, as in the lintels of the doors, formed by irregular stones laid as rough voussoirs. The columns and arches of the courtyards, were also constructed with irregular masonry (Fig. 11).

11. Column and capital made with rubble masonry and gypsum mortar.

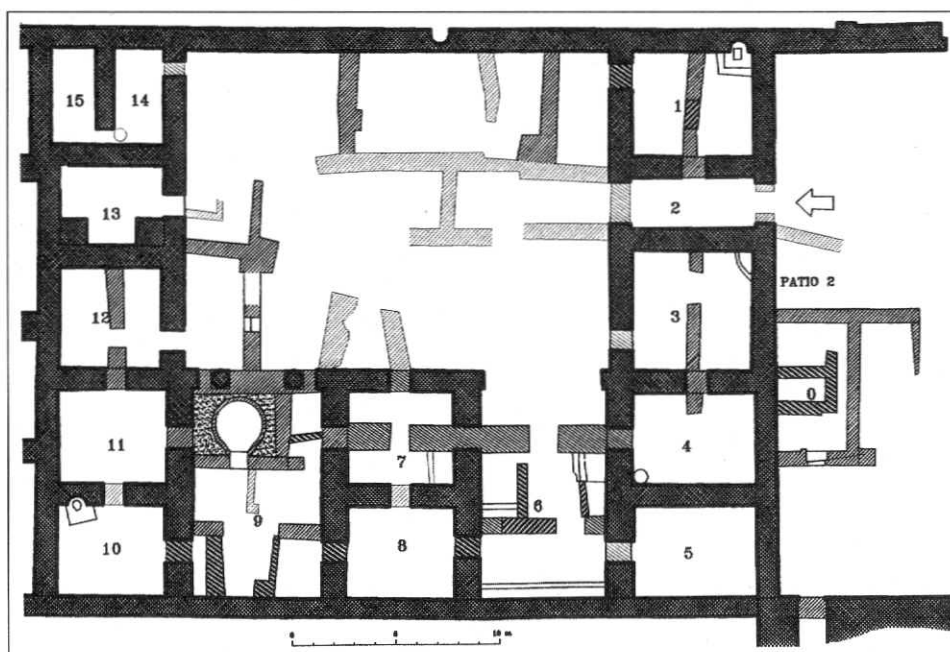
12. Late structures in building F.

After its violent destruction, Building F was partially reoccupied (Fig. 12). Some rooms that had withstood the earthquake were partitioned and converted into domestic units, to which the adjacent part of the courtyard was added, partially cleared of

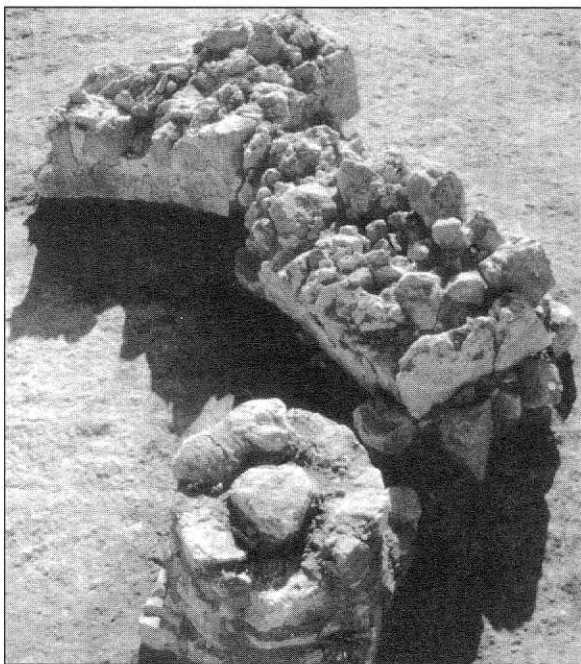
13. Base, column and arch collapsed in the courtyard.

This is the space which provides the clearest evidence of the effects of the earthquake. On the paving we can find an important amount of rubble reaching a height of more than 1 m in some areas, acting as a support for the columns and arches of the portico, broken and shattered on the floor of the palace.

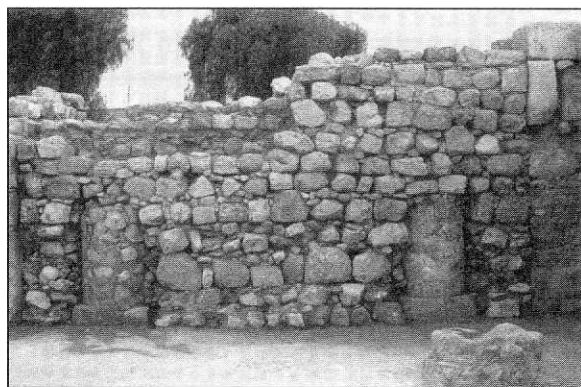
14. The west *iwān* blocked by late structures.
