1 Hydro-geomorphological consequences of the abandonment of agricultural terraces in  
2 the Mediterranean region: key controlling factors and landscape stability patterns

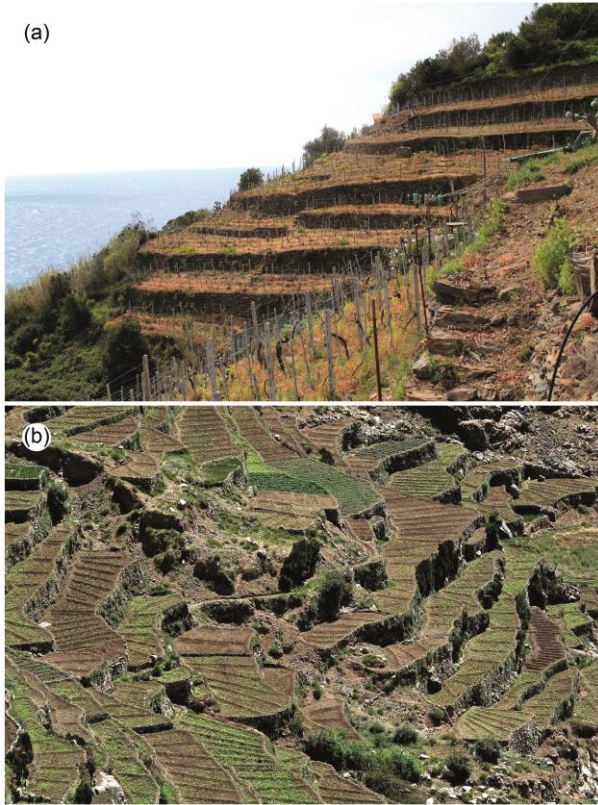
Fig. 1.

1558 Figure 1. Active traditional cultivation terraces in the Mediterranean region: (a) Cinque  
1559 Terre (Italy) protected denomination-of-origin terraced vineyards; (b) subsistence  
1560 agricultural terraces in Amenzel (Marrakech Atlas, Morocco). Image authorship: (a)  
1561 photo by [Arsheffield](#); licensed under [CC BY-NC 2.0](#); (b) photo courtesy of Jean Claude  
1562 Latombe.

127 (Fig. 1b) and the implementation of DRS (*Défense et Restauration des Sols*) campaigns  
128 for soil conservation since 1950 have contributed to the preservation of these traditional  
129 structures (Heusch, 1986; Barow and Hicham, 2000; Montanari, 2013).

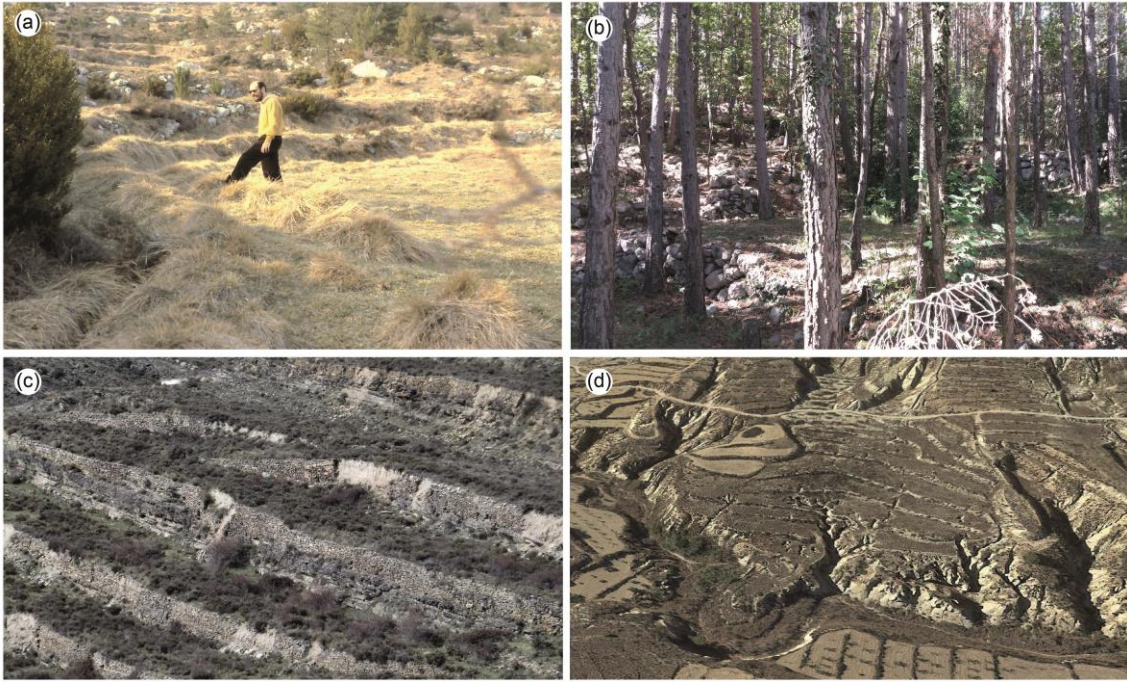
Fig. 2.

1564 Figure 2. Contrasting hydro-geomorphological results of terrace abandonment in  
1565 Mediterranean landscapes: dense colonization of (a) grass and (b) pine forest cover  
1566 provides strong stabilization of abandoned terraces in (left) Cal Parisa and (right) Can  
1567 Vila (Vallcebre catchments, Catalan Pyrenees, NE Spain); (c) progressive degradation  
1568 of terrace risers by the effects of small soil slips and dry-stone wall collapses in Camero  
1569 Viejo (Iberian Range, N Spain); (d) gully expansion by aggressive piping/tunnelling  
1570 phenomena in abandoned terraces of the Rambla de Algeciras (Murcia, SE Spain).  
1571 Image source/authorship: (a) F. Gallart, (b) M. Moreno-de-las-Heras, (c) photo courtesy  
1572 of José Angel Llorente, (d) Moreno-de-las-Heras and Gallart (2018).

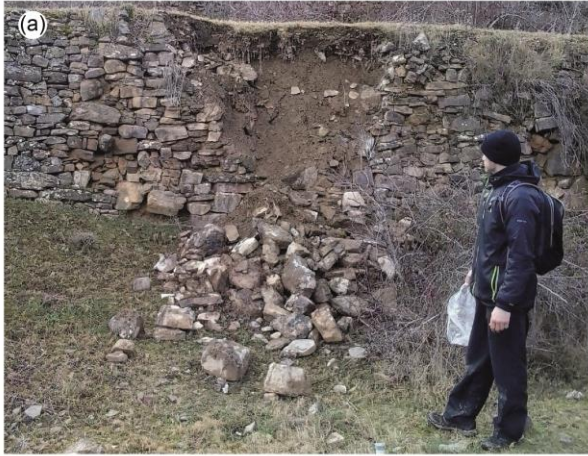
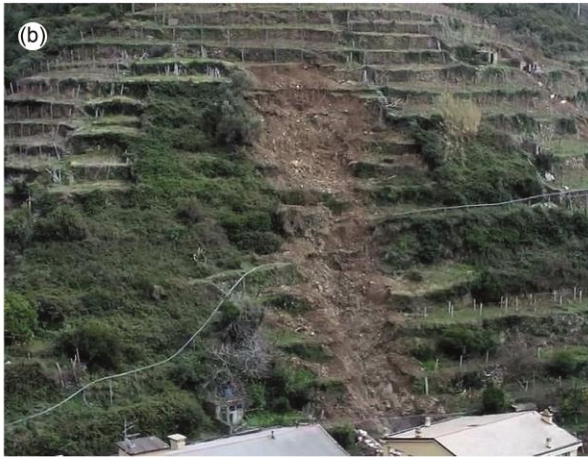
Fig. 7.

1620 Figure 7. Mass movements: (a) small soil slip affecting the wall of an abandoned terrace  
1621 (Camero Viejo, Iberian Range, N Spain); (b) terrace-cascading landslide triggered by  
1622 extreme rainfall (the 25 October 2011 event) in abandoned terraces of the Vernazza  
1623 basin (Cinque Terre, Liguria, Italy); (c) key factors controlling the activity of mass  
1624 movements in abandoned terraced landscapes. The size of the bars in (c) indicates the  
1625 relative frequency of citation (% of sites) of the identified key factors in the  
1626 bibliographic references of the terrace sites explored in this study. Bar and arrow  
1627 colours indicate the direction of the geomorphological impact (green, positive; red,  
1628 negative) for the key factors. Image authorship: (a) N. Lana-Renault, (b) photo courtesy  
1629 of Ruth Manfredi (Save Vernazza ONLUS).

850 shallow landslides, mostly on steep (>45% slope) terraced hillslopes over impermeable  
851 and semi-permeable (claystone/siltstone) bedrock, which contributed to the formation  
852 downstream of a catastrophic debris flood affecting the village of Vernazza (Cevasco et  
853 al., 2013, 2014). Landslides and floods in the basin caused three casualties and nearly  
854 €130 million damage to buildings and infrastructure. Debris slides and terrace-  
855 cascading avalanches severely affected abandoned terraces during this event (Fig. 7b),  
856 mobilizing over 33,000 m<sup>3</sup> km<sup>-2</sup> of eroded soil (Brandolini et al., 2008). Similar effects  
857 were reported for a montane Mediterranean area in the Catalan Pyrenees (upper  
858 Llobregat basin, NE Spain), where a ~100-yr return-period event in November 1982  
859 accumulated up to 350 mm rainfall in 48 h, causing 616 shallow slips and landslides in

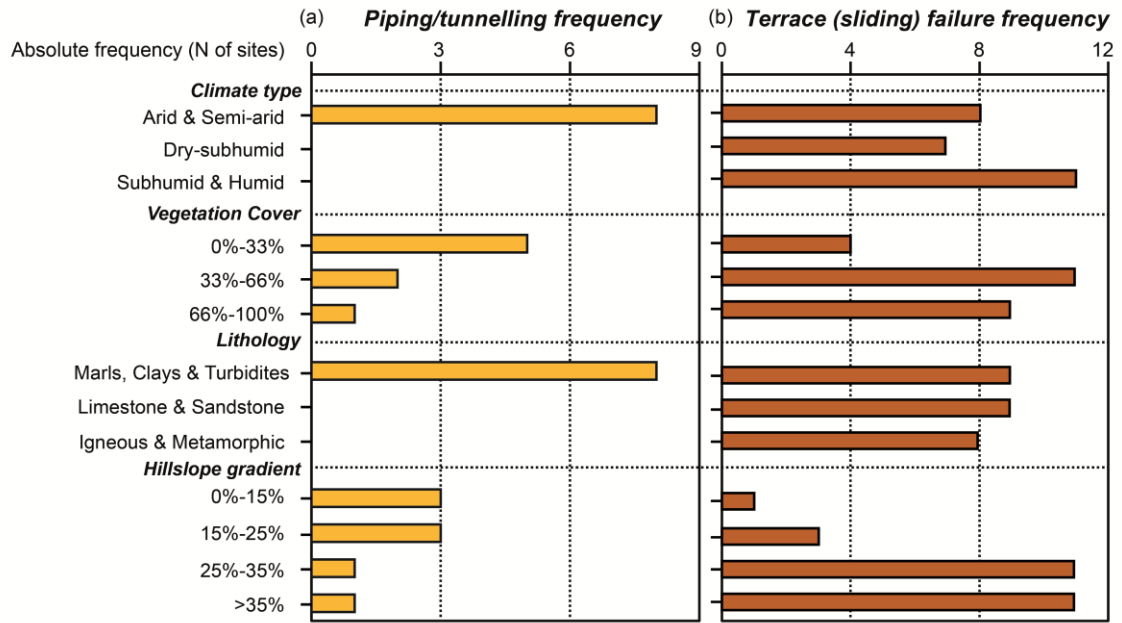
Fig. 10.

1660 Figure 10. Absolute frequency distribution (number of sites) of terraced landscapes  
1661 reported in the explored bibliography to have suffered: (a) aggressive piping/tunnelling  
1662 phenomena and (b) mass wasting problems (i.e., terrace sliding failure) in relation to  
1663 their local environmental characteristics (i.e., climate type, vegetation cover, local  
1664 lithology and hillslope gradient).

813           Analysis of the absolute frequency of sliding failure phenomena for the sites  
814 explored in this study showed that mass movements are critically concentrated in high-  
815 gradient landscapes (>25% slope; Fig. 10b), markedly reducing the relative frequency  
816 of landscapes with stable (non-erosive) terrace behaviour in steep systems (Fig. 9). In  
817 fact, mass movements constitute major destabilizing phenomena for abandoned terraced  
818 sites on high-gradient hillslope landscapes. Jiménez-Olivencia (1990), for instance, in a  
819 catchment-scale study of old (about 30 yr) abandoned terraces on a steep (20%-80%  
820 gradient) mountain landscape near Sierra Nevada (Acequia de Cachariche, southern  
821 Spain), reported that terrace collapses massively affected extremely steep (>50% slope)  
822 hillslope sections, while abandoned systems located on moderately steep (<30%

862         Interestingly, we found a high frequency of terraced landscapes affected by the  
863 action of mass movements at sites showing moderate to extensive vegetation cover (Fig.  
864 10b). In most cases, short- to decadal-term scrub vegetation development showed little  
865 capacity to reduce the occurrence of mass movements (Lehmann, 1993; Cammeraat et  
866 al., 2005; Morel, 2006; Koulouri and Giorgia, 2007; Paliaga et al., 2016). For example,  
867 landslide mapping and analysis for the Vernazza basin after the 25 October 2011 heavy  
868 rainfall indicated that the highest percentage of landslide scars in the area were found in  
869 well-vegetated, abandoned terraces (Cevasco et al., 2014). Similarly, Koulouri and  
870 Giorgia (2007) in (up to 20 yr) abandoned cultivation terraces of Lesvos (Greece)  
871 indicated that, despite widespread development of shrub vegetation (in some cases over
