1 **Assessing sinkhole activity in the Ebro Valley mantled evaporite karst using**
2 **advanced DInSAR**

19 **Abstract**

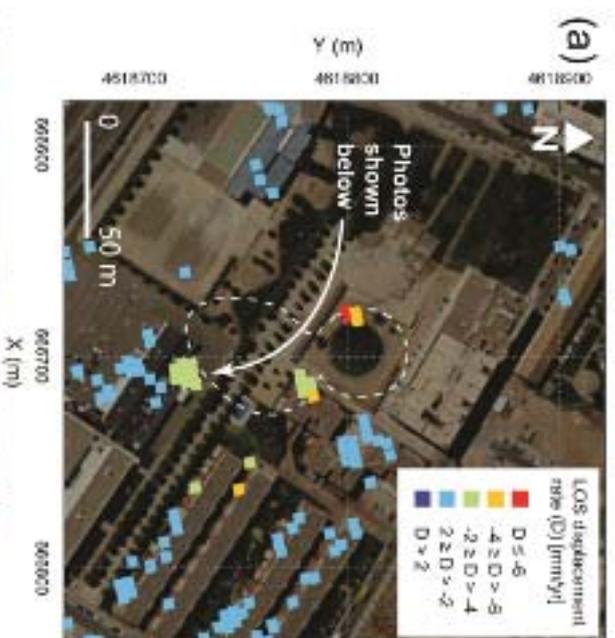
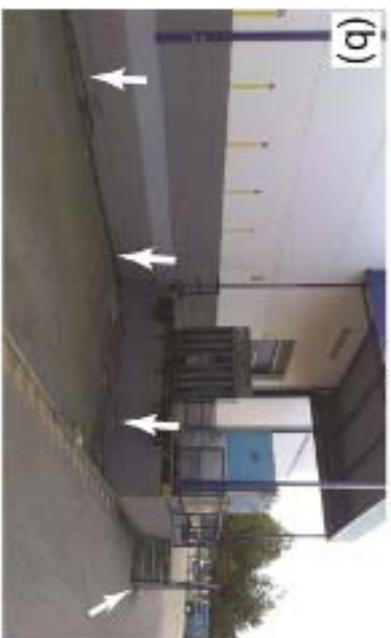
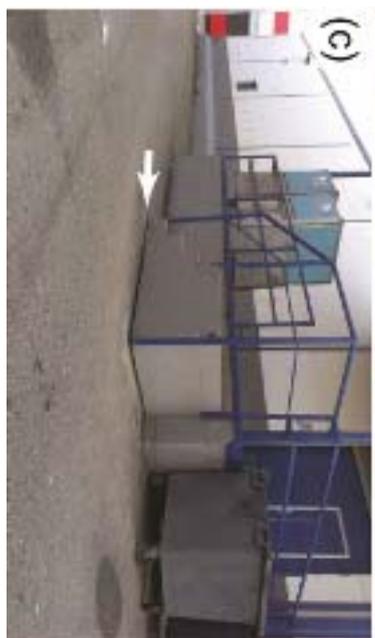
995 Figure 13. Examples of structural damage within Sinkhole B2. Fissures (A), cracks (B)
996 and open joints (D) observed in building walls. Road affected by fissures and scarplets
997 (C). Traffic sign tilted (E and F) towards the main sinking centre of the area.

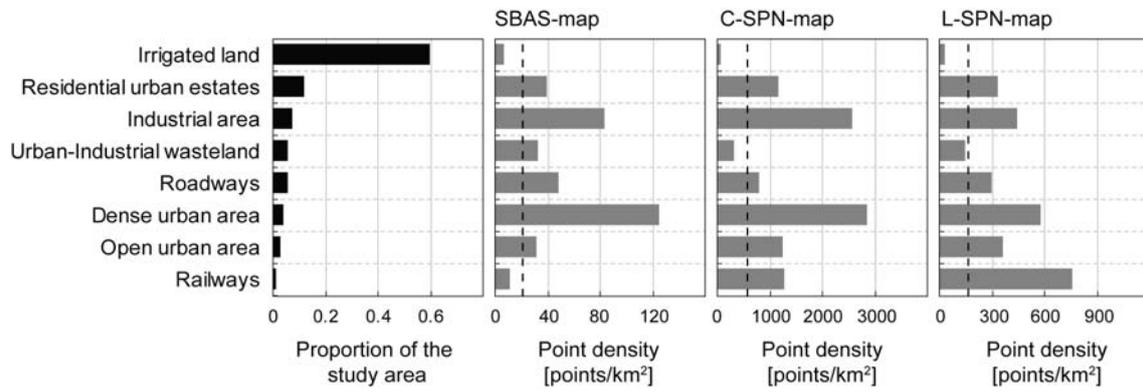
Figure S1. Proportion of the study area occupied by different land covers and density of measurement points for the different land covers in each DInSAR map. Vertical dashed lines indicate the overall density of points in the study area.

288 The density of measurement points (i.e. PS or pixels, according to the technique) in the
289 SBAS-, C-SPN- and L-SPN- maps are 26, 597 and 156 points/km², respectively. In the
290 three maps, the lowest density of points occurs in irrigated lands, whilst the highest
291 densities occur in urban and industrial zones. The density of measurement points for the
292 different land covers in each DInSAR map can be found in the online Supplementary
293 Material (Fig. S1).
