Amman Citadel, Umayyad Palace. Antonio Almagro, Julio Navarro, and Antonio Orihuela report on the 1989 season of excavation and restoration of the Umayyad Palace on the Amman Citadel:

Wadi Jerash. Gaetano Palumbo, ACOR and Università di Roma, reports:

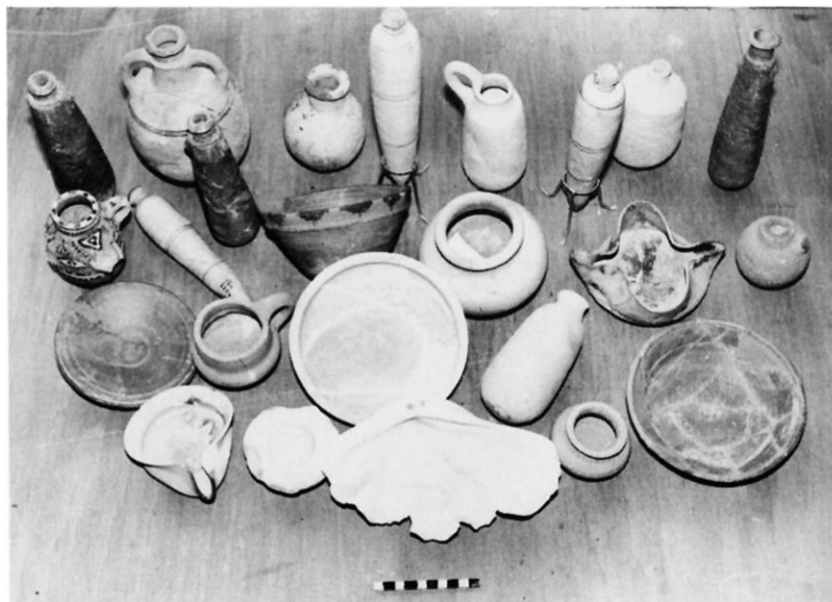
Fig. 26. Amman Citadel, Temple of Hercules. Seventh-century B.C. Ammonite objects.

Probably the most significant result of the 1990 seasons is the discovery of the remains of an Ammonite temple. Although there was no direct evidence for the function of the building discovered to the east of the Roman temple (due to limited area of the excavations and the disruption of the building in the Roman period by the construction activities of the Roman temple), the nature of the finds suggests that the building may have served a special cultic community function (fig. 26).

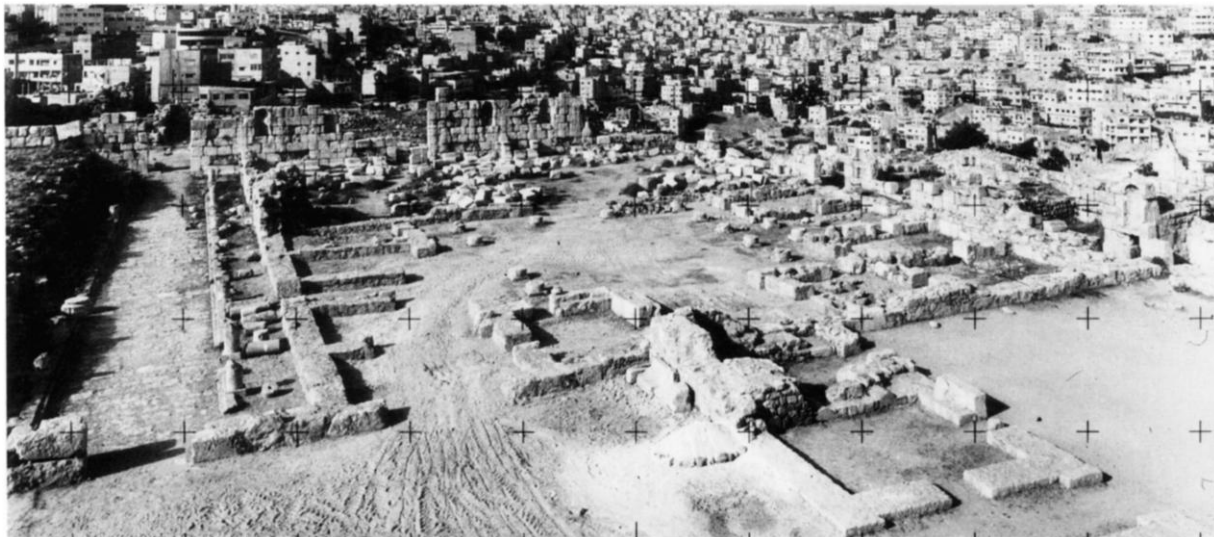
Fig. 27. Amman Citadel, Umayyad Palace. Building B after partial restoration.

One of the purposes of our work was the restoration of one of the residential areas of the Palace, the central building of the east side, "building B," after A. Almagro (*El palacio omeya de Amman*, Madrid 1983). This building (fig. 27) had nearly disappeared during the excavations of the Italian Mission in the '30s and with more recent work in the early '70s, both of which concentrated on the recovery of the Roman carved stones and ashlar reused by the Umayyads in their rubble walls.

Following the plans drawn by the Italian Mission and the remains of Umayyad foundations, it was possible to rebuild the Umayyad walls up to a height of 60–70 cm in order to help the visitor visualize the ground plan of the Umayyad building.

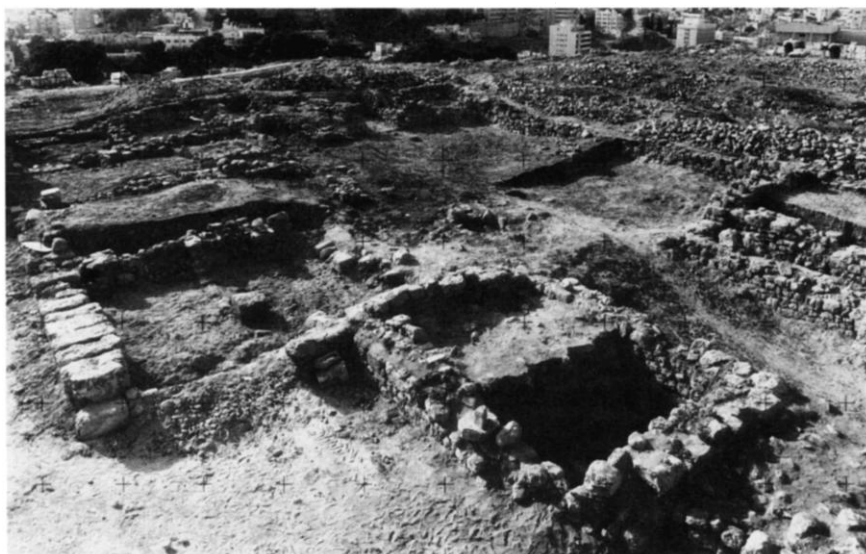
Fig. 28. Amman Citadel, Umayyad Palace. Building F area during excavation.

(fig. 28), which is situated west of courtyard 2 and is one of the six residential units that the Umayyads built inside the Roman temenos.

After delimiting the walls we realized that the hypothetical plan drawn by Almagro in 1983 was correct in the main lines, as the building has a courtyard with ranges of rooms on only three sides: east, south, and west. Both east and west ranges have five rooms or

spaces each, while there are only three on the south side. Although the number of rooms is the same as we expected, their size and shape are different. The entrance is not in the axis of the east facade but north of it. The staircase is in the west range, exactly in front of the entrance. Another difference is that the south range is deeper than the others and, therefore, the courtyard is rectangular in shape, instead of square.
