Hydrogeomorphological analysis and modelling for a comprehensive understanding of flash-flood damage processes: the 9 October 2018 event in northeastern Mallorca

Abstract. A flash-flood event hit the northeastern part of Mallorca on 9 October 2018, causing 13 casualties. Mallorca is prone to catastrophic flash floods acting on a scenario of deep landscape transformation caused by Mediterranean tourist resorts. As global change may exacerbate devastating flash floods, analyses of catastrophic events are crucial to support effective prevention and mitigation measures. Field-based remote-sensing and modelling techniques were used in this study to evaluate rainfall–runoff processes at the catchment scale linked to hydrological modelling. Continuous streamflow monitoring data revealed a peak discharge of $442 \text{ m}^3 \text{ s}^{-1}$ with an unprecedented runoff response. This exceptional behaviour triggered the natural disaster as a combination of heavy rainfall (249 mm in 10 h), karstic features and land cover disturbances in the Begura de Salma River catchment (23 km^2). Topography-based connectivity indices and geomorphic change detection were used as rapid post-catastrophe deci

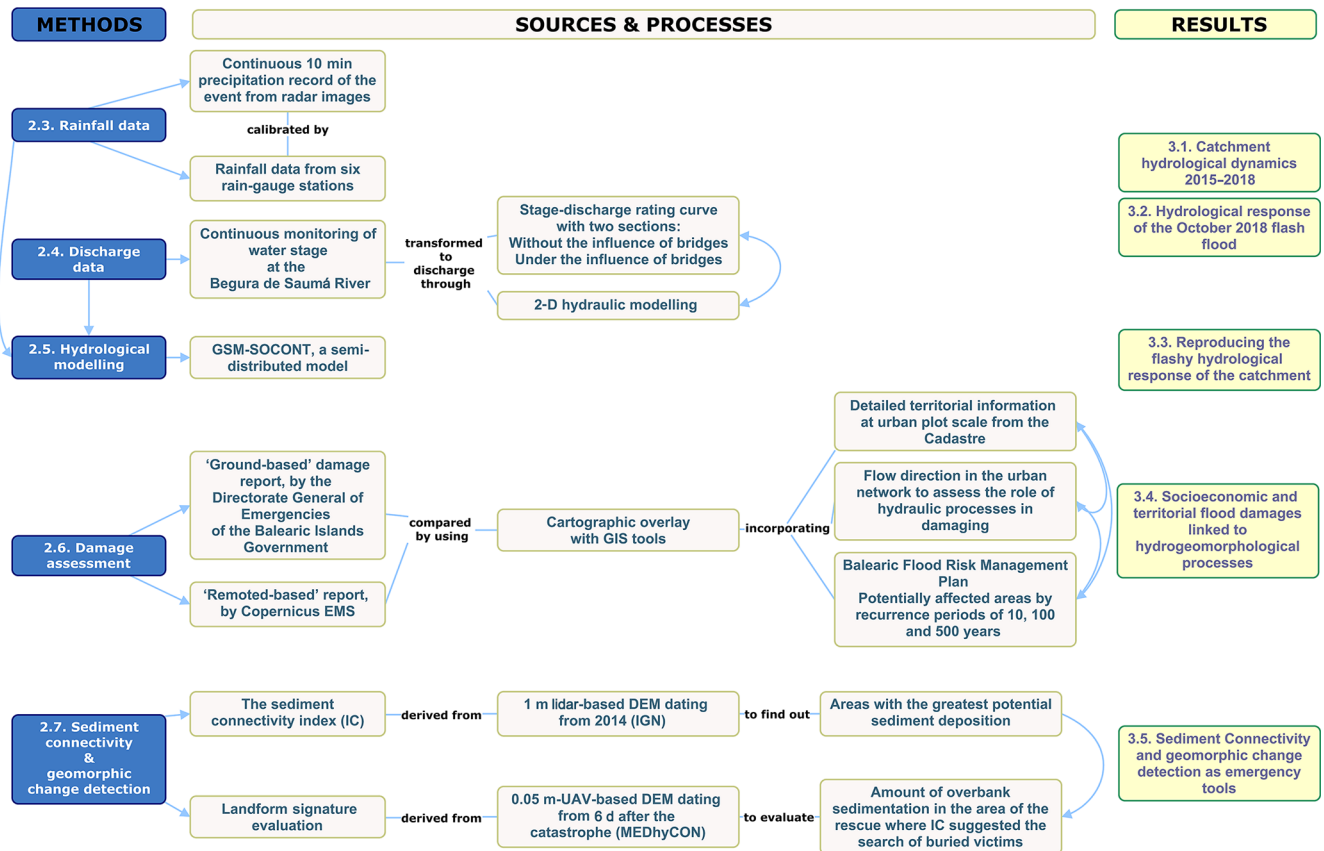
Figure 1. Workflow of the experimental design.

charge was developed through the analysis of the rainfall-runoff processes at a small spatial scale during this extreme event. Likewise, this analysis was linked to hydrological modelling to check the internal consistency of the information gathered by instruments and to flood damage and losses at the village of Sant Llorenç des Cardassar. Finally, HR-DTMs were generated by lidar 2014 data from the Spanish National Geographic Institute and by imagery captured through a low-cost UAV just 6 d after the catastrophe, to calculate a sediment connectivity index (IC) and measure geomorphic changes (Fig. 1).

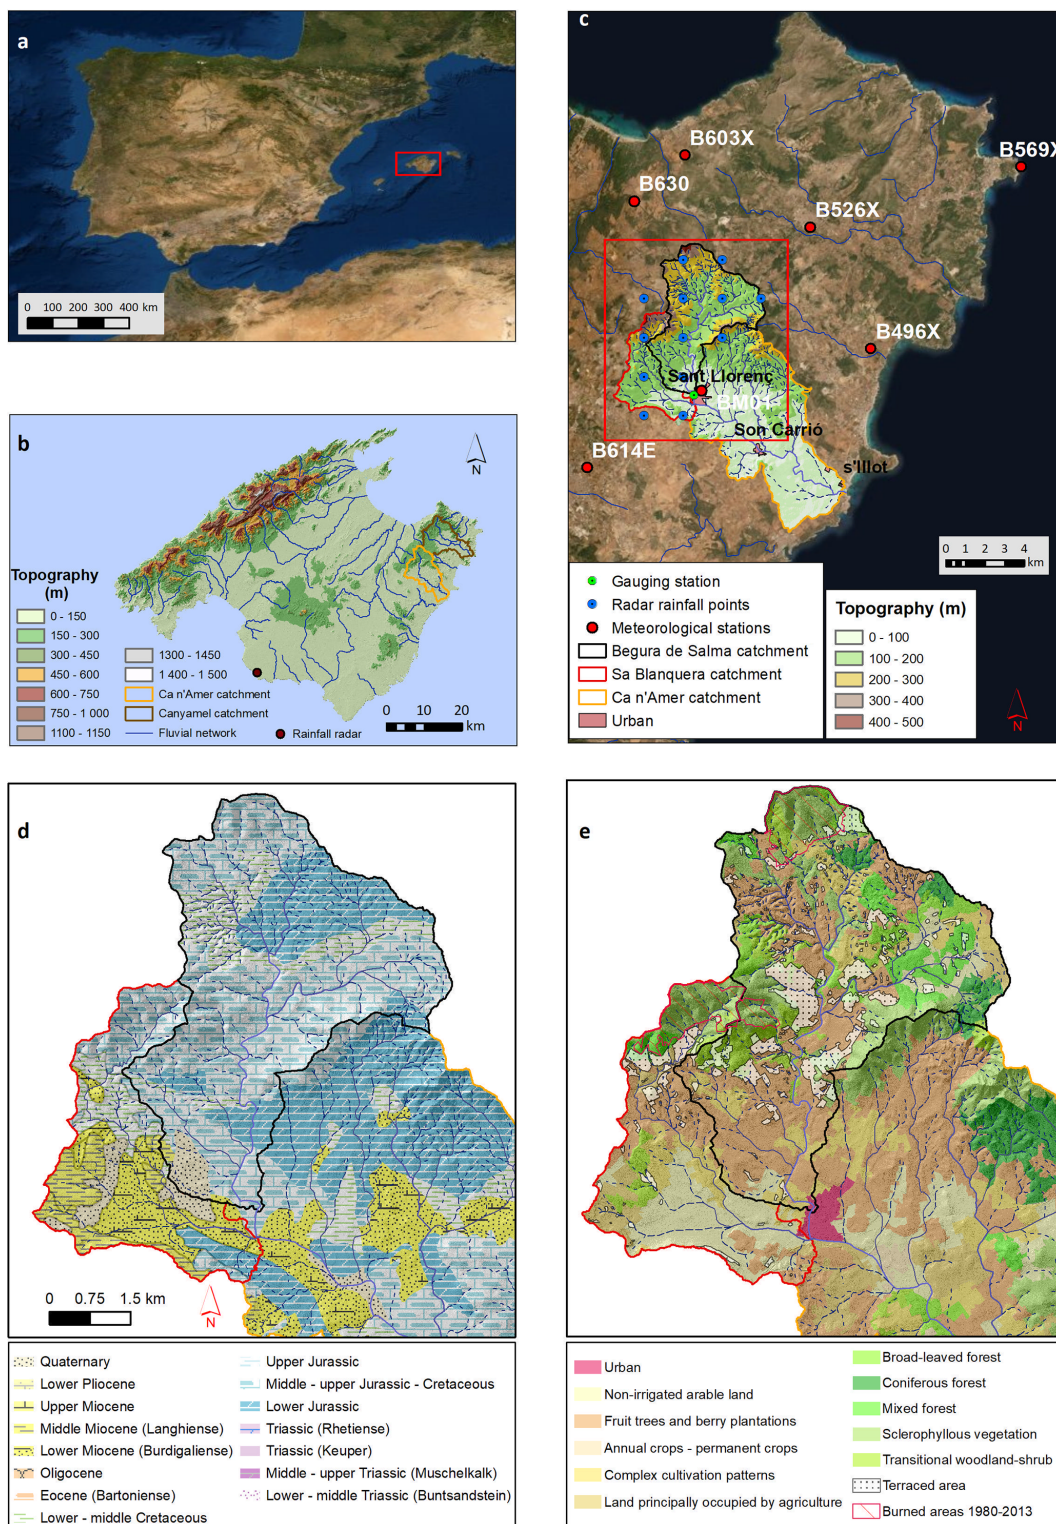
Figure 2. Main characteristics of affected basins during the 9 October 2018 flash flood. **(a)** Location of Mallorca in the western Mediterranean. **(b)** Topography and fluvial network of Mallorca with the location of the main basins affected: Canyamel and Ca n'Amer rivers. **(c)** Sa Blanquera and Begura de Salma headwater river catchments within the Ca n'Amer River, with locations of rainfall and hydrometric stations; and radar rainfall points derived from a regular mesh of 1×1 km. Source: <https://opendata.aemet.es> (last access: 15 May 2020). Background: aerial photography and DTM data (PNOA, 2015). **(d)** Lithology of both the Sa Blanquera and Begura de Salma catchments. **(e)** Land use and terraced areas for the same headwater catchments. Source: Corine Land Cover (2018).

mostly located in lowland areas. Forest (26 %) and scrubland (17 %) were predominant at headwaters. Terraced fields still occupied 10 % of the catchment, although most of them were abandoned (Fig. 2e). In 1956, natural vegetation covered 21 % of the catchment. This rose to 42 % in 2012 due to an afforestation process of former agricultural land in the second half of the 20th century. In combination with other factors, afforestation triggered a higher fire risk: two wildfires burned an area of 1.7 km²: 17 % in 1983 and 83 % in 2011 (Balearic Forestry and Soil Conservation Service; <http://xarxaforestal.caib.es>, last access: 15 May 2020; Fig. 2e). The climate of the area is classified as Mediterranean temperate sub-humid on the Emberger scale (Guijarro, 1986). Mean annual rainfall (1968–2018, B630 Spanish Meteorological Agency (AEMET) station; see Fig. 2c) is 652 mm yr⁻¹. A rainfall amount of 140 mm in 24 h was estimated to have a recurrence period of 25 years (YACU, 2003).

The 9 October storm affected the two northernmost catchments of Llevant county, i.e. the Ca n'Amer and Canyamel rivers (Fig. 2) with nine and four casualties, respectively, and significant damage. The synoptic situation was characteristic

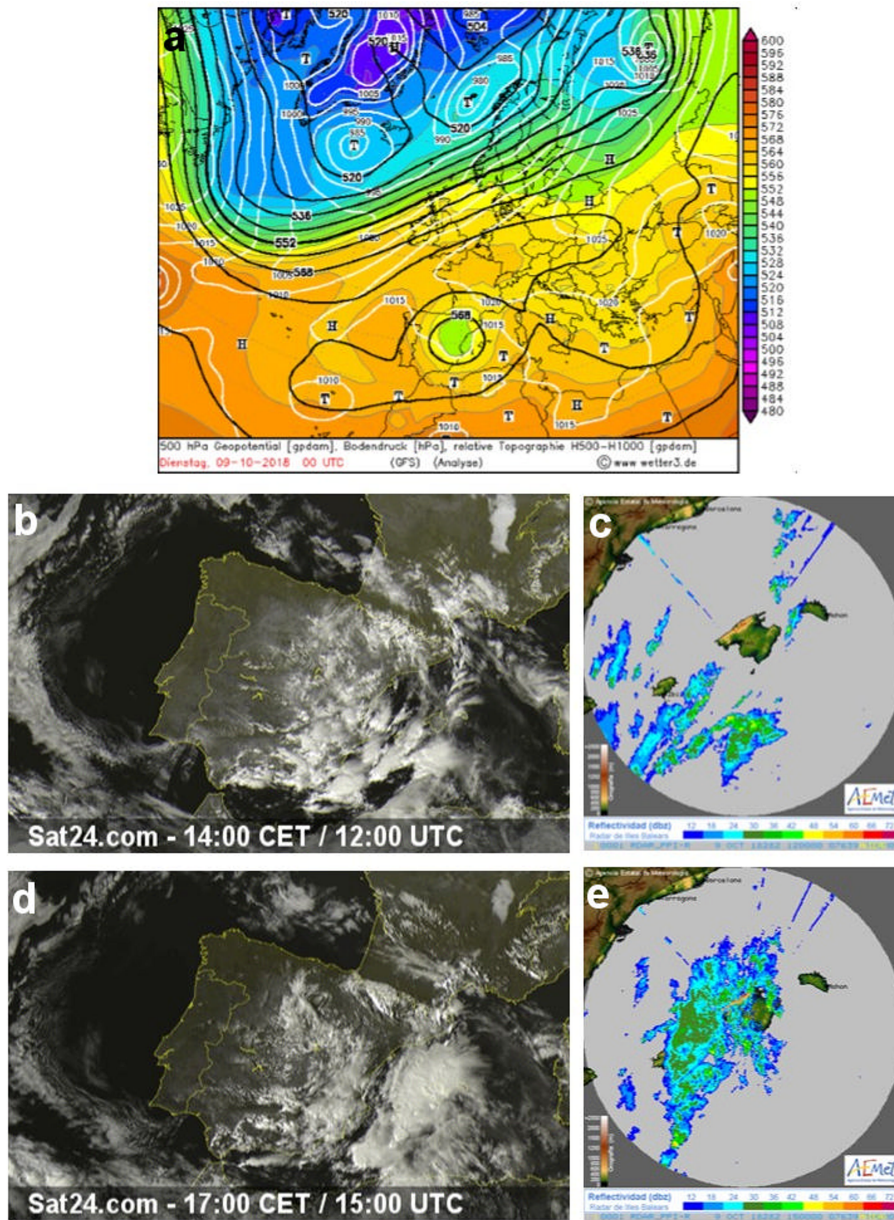
Figure 3. (a) Surface pressure and 500 hPa height analyses at 12:00 UTC on 9 October 2018 (source: <http://wetter3.de> (last access: 15 May 2020), i.e. at the beginning of the precipitation event. Satellite image at (b) 12:00 UTC and (d) 15:00 UTC (source: <http://www.sat24.com>, last access: 15 May 2020). EUMETSAT and radar images are shown for the same hours (c, e) (source: <http://www.aemet.es>, last access: 15 May 2020).

of flash-flood events in the Western Mediterranean (Fig. 3a). A cut-off low at midlevel was located in the eastern part of the Iberian Peninsula and shallow low-level pressure affected the same region, driving warm and wet air from the Mediterranean Sea to the Balearic Islands and the eastern part of the Iberian Peninsula. This occurred in early October, when the sea surface temperature is close to its annual maximum in the Western Mediterranean, providing high quantities of moisture. Moreover, the cut-off low showed a typical divergence at midlevel on its eastern flank, affecting the Balearic Islands and favouring the development of deep convection. Convection started on the sea between the Balearics and the Iberian Peninsula (Fig. 3b and c) and, due to SW winds at mid-tropospheric levels, the convective cells started to move towards the Balearics, where heavy rainfall triggered the flash-flood event (Fig. 3d and e).

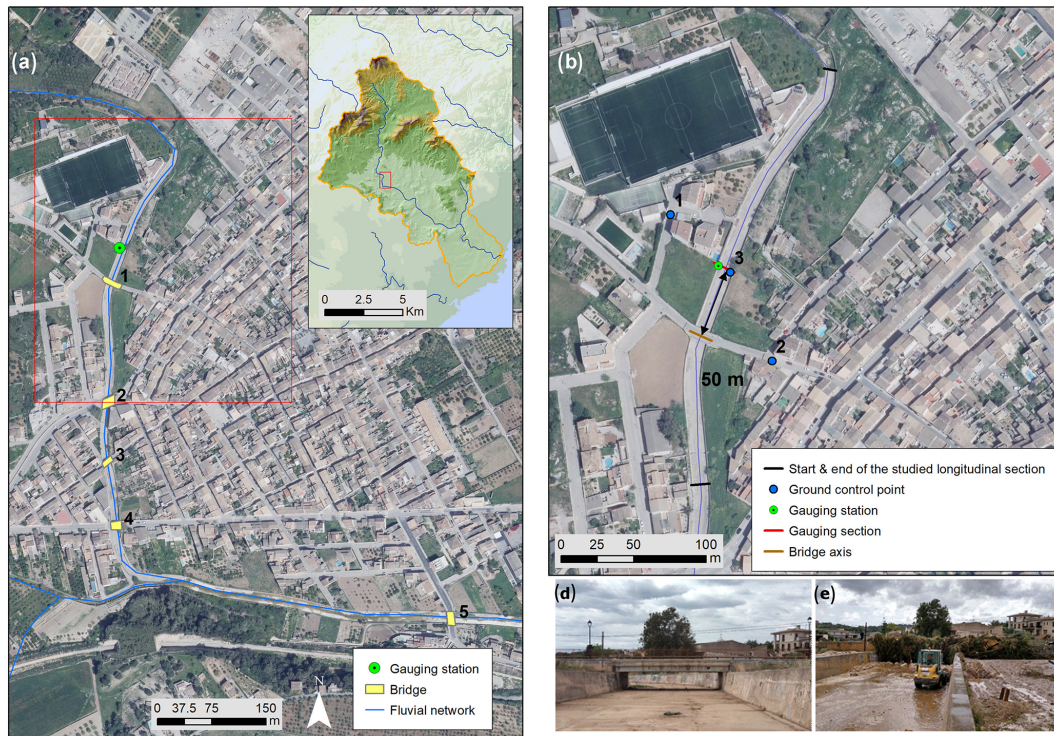
Figure 4. (a) Aerial view of the concrete channel of the Begura de Salma River that crosses the village of Sant Llorenç des Cardassar and the location of bridges. (b) Detailed aerial view of the very beginning of this concrete channel, where the hydrometric station is located. The photographs show a view of bridge 1 from the hydrometric station when (d) the digital equipment was installed on 10 June 2015 and (e) a few hours after the flash flood, on 10 October 2018. Background: aerial photography and DTM data (PNOA, 2015).

The SDRC was divided into two sections. The first was related to a scenario where bridges do not affect the hydraulic function at the gauging section, despite flow being bankfull or even overbanking the channel. The second section was a scenario under the influence of bridges, i.e. the flow below them and also over their decks. It is then clear that the design, dimensions and proximity to the hydrometric station of these bridges affected directly flow behaviour at the hydrometric station due to obstruction (see pictures in Fig. 4). The obstruction of bridge 1 occurred when the upstream section of the concrete channel reached the bankfull level, such that dragging and floating elements began to collide against the back of the bridge, triggering the obstruction process. Consequently, the hydraulic model had to integrate the obstructions observed at the downstream bridges, at least the two nearest ones (Fig. 4a). These post-event pictures and maximum water stages observed in situ 10 h after the event were useful for calculating the obstruction percentages of these two bridges: 85 % at bridge 1, 40 % at bridge 2 and with no obstruction at the other ones. The overbank flow coefficients were 2.2 for bridges 1, 4 and 5, and 2.1 for bridges 2 and 3. The SDRC obtained allowed calculation of this phenomenon, which is activated with Q values ranging 130–160 m³ s⁻¹. Nevertheless, calibration of the hydraulic model of overbank flow coefficients and the degree of obstruction of these structures was needed and attained by complete flow equations (full momentum) without changes in boundary conditions. For this purpose, the WS calculated in open-channel conditions were compared with those WS observed in the field during and after the event in the hydrometric station and its surrounding floodplain area. Maximum WS observed in situ 10 h after the event, within a period of time in which the high-water marks could still be seen, were mapped through ground control points. Three of them were selected as representative locations around the hydrometric station (Fig. 4b), and the maximum WS reached at the hydrometric station (4.55 m) was also included. The modelling results in open-channel

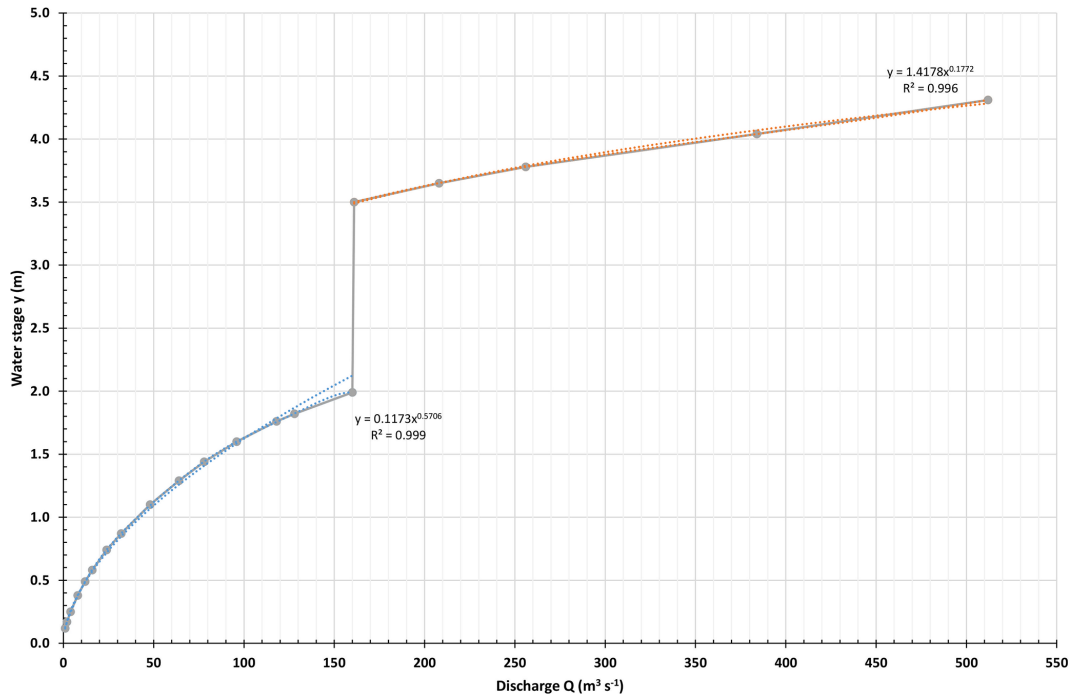
Figure 5. Stage–discharge rating curve performed by means of two-dimensional hydraulic modelling with two differentiated sections in accord with the influence of bridge 1 (see Fig. 3a) and its potential obstruction.

The SDRC was finally designed (see Fig. 5), showing clearly the two differentiated sections with a gap between them in WS of approximately 1.5 m because 1.4 m is the edge of road bridge 1 located just 50 m downstream from the hydrometric station. The SDRC is fitted to a power equation for both sections, obtaining high values of significance ($R^2 > 0.990$). Thus, in the case of the first section of the SDRC, the adjustment was R^2 of 0.999, operating in open-channel flows up to $160 \text{ m}^3 \text{ s}^{-1}$ in bankfull conditions or even overbanking the channel but always without the bridges' influence. The second section, with a R^2 of 0.996, defined for $Q > 160 \text{ m}^3 \text{ s}^{-1}$, was already influenced by the presence of the bridges, i.e. in open-channel flows but conditioned by the backwater generated in the flow under pressure inside the span of bridge 1 as well as over its concrete decks.

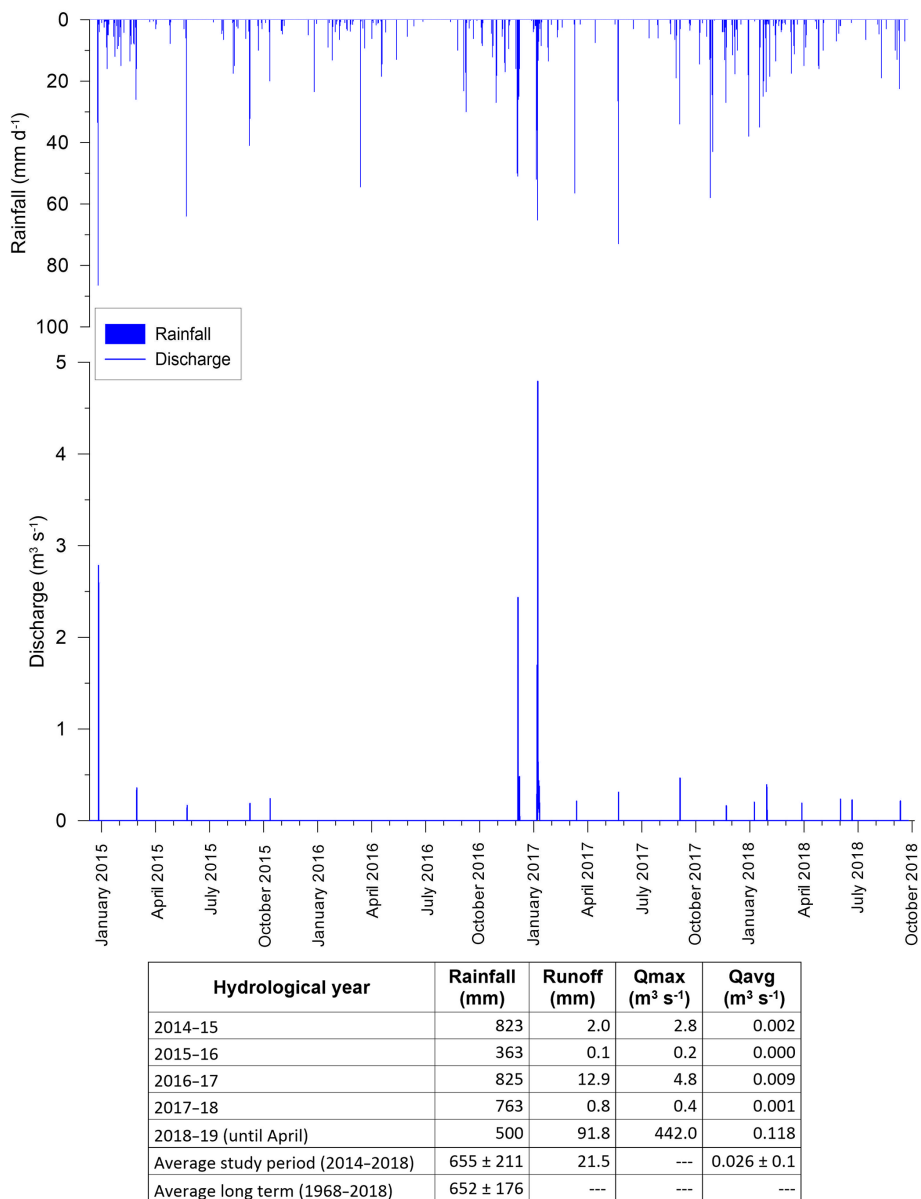
Figure 6. Discharge at 15 min intervals measured at the MEDhyCON hydrometric station located at the beginning of the concrete channel of the Begura de Salma River in Sant Llorenç des Cardassar. Likewise, the daily rainfall measured at the AEMET-B630 Ses Pastores during the monitored period (10 January 2015–30 September 2018), prior to the catastrophic flash flood of 9 October 2018, is shown. The bottom table displays the rainfall, runoff and peak discharge for hydrological years during study period. Rainfall data are from AEMET-B630 Ses Pastores, located 10.5 km from the Begura de Salma River catchment outlet and representative of the rainfall dynamics of the Llevant range’s headwaters.

The hydrological monitoring period assessed in this paper by using data from the hydrometric station was from 10 January 2015 to 30 September 2018 (Fig. 6). The month of October 2018 was reserved for a singular and deeper study that could describe the catastrophic flash-flood event better (see results, Sect. 3.2). This gives a series of almost 4 hydrological years under hydrometeorological conditions illustrating ephemeral behaviour of the Begura de Salma River that was average in terms of precipitation (see the inset table, Fig. 6). In terms of Q , this inset table also shows the behaviour during the study period of several hydrological parameters. However, these values cannot be compared in the long term due to errors of up to 2 orders of magnitude in Q values measured by the hydrometric network managed by the Balearic Islands Government (see Fortesa et al., 2019). Events of different magnitudes occurred during this study period, some of them representative of recurrence ≈ 5 years in terms of rainfall. However, only two events recorded peak Q (hereafter Q_{peak}) values $> 1 \text{ m}^3 \text{ s}^{-1}$, both occurring in January, when the hydrological pathways were fully active due to saturation processes. In January 2015, 120 mm of rainfall in 48 h at the AEMET-B630 Ses Pastores rainfall station (see location in Fig. 2) created a flow response with a Q_{peak} of $2.8 \text{ m}^3 \text{ s}^{-1}$. Finally, in January 2017, 153 mm of rain fell in 72 h with a Q_{peak} of $4.8 \text{ m}^3 \text{ s}^{-1}$, the maximum recorded at the hydrometric station during the study period before the catastrophic flash flood.

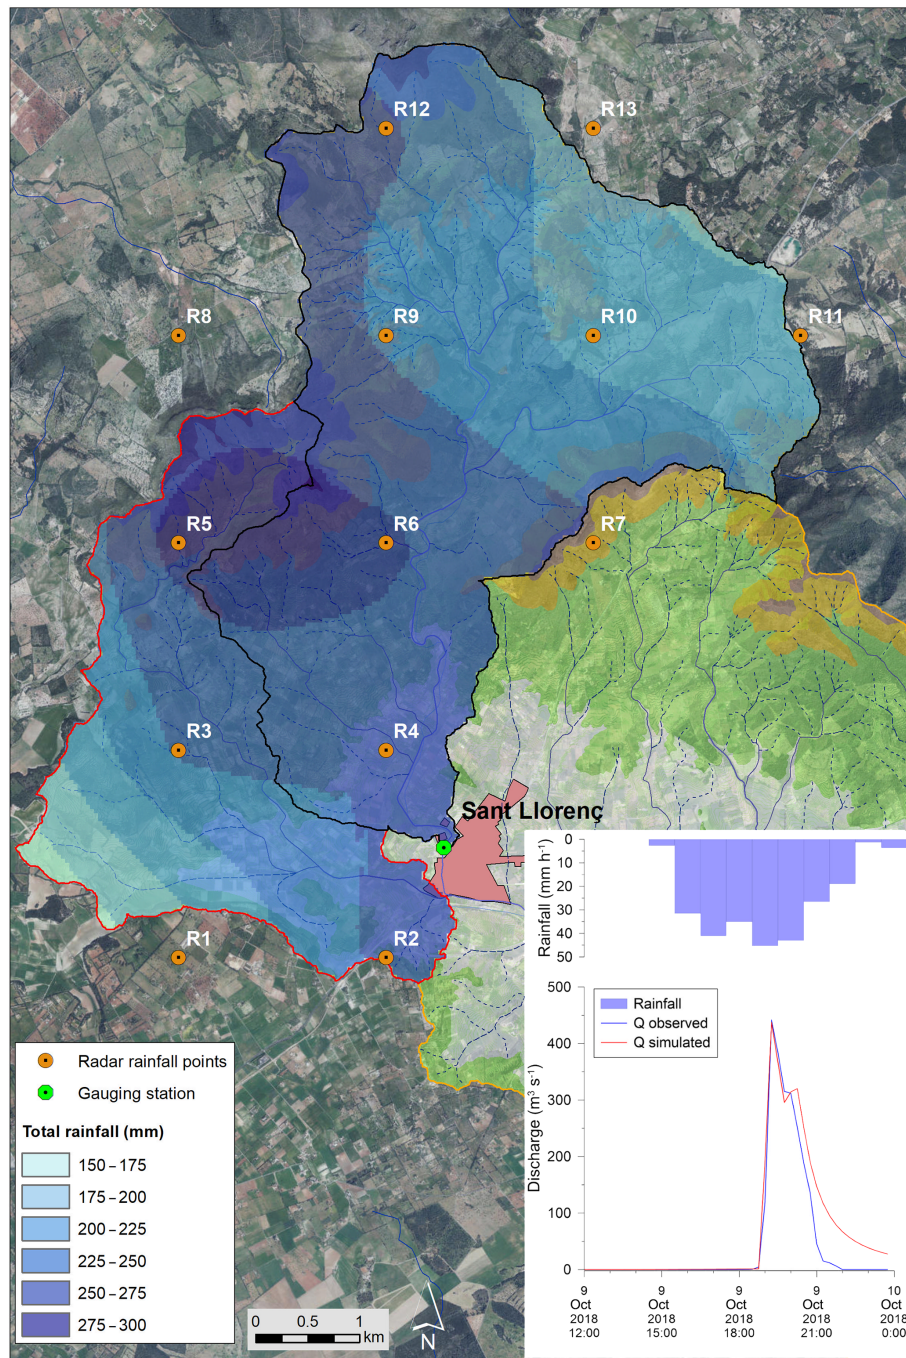
Figure 7. Map of isohyets of the rain storm of 9 October 2018 in the two headwater catchments of the Ca n' Amer River, i.e. the Sa Blanquera River and Begura de Salma River. Source: 10 min radar images obtained from the web <https://opendata.aemet.es/> (last access: 15 May 2020). The inset figure shows the discharge measured at the MEDhyCON hydrometric station, as well as the result of the rainfall–runoff simulation using a modified version of the GR3 model. Background: aerial photography and DTM data (PNOA, 2015).

aged buildings were found (Fig. 7f) in zones 2 and 3. It is worth noting that the post-event definition of the Copernicus EMS (Copernicus Emergency Management Service, 2018) covered approximately 90 % of the real damage.

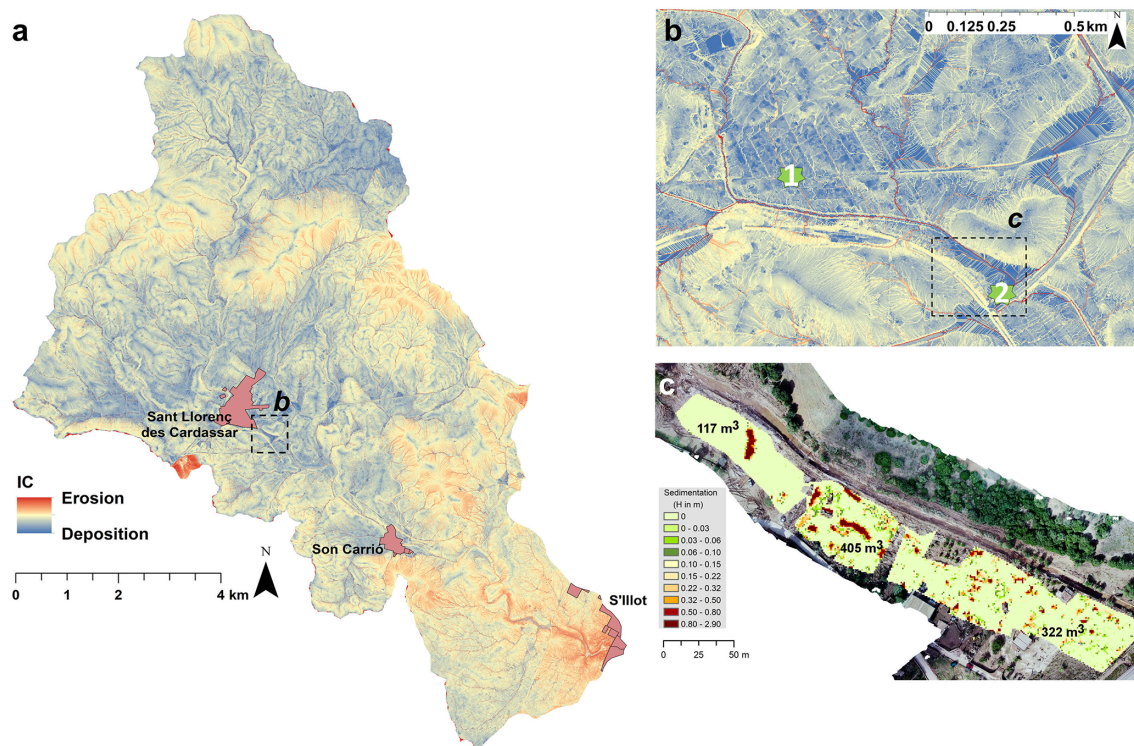
Figure 9. Spatial patterns of hydrological and sediment connectivity (deposition zones in blue colours) (a) in the Ca n' Amer River basin, (b) in the southeastern part of Sant Llorenç des Cardassar with numbers indicating (1) the point where the missing person was last seen and (2) where this person was found by using this connectivity index from a 2 m resolution digital terrain model (DTM) (Instituto Geográfico Nacional, 2014). (c) Overbank sedimentation estimated after the flash flood from a DTM performed with SfM from a UAV flight (15 October 2018) in relation to the ground points of the 2014 lidar data. Background aerial orthophotography of approximately 2 cm resolution also obtained from the drone images. Numbers indicate the total volume of deposited sediments in the three areas measured.

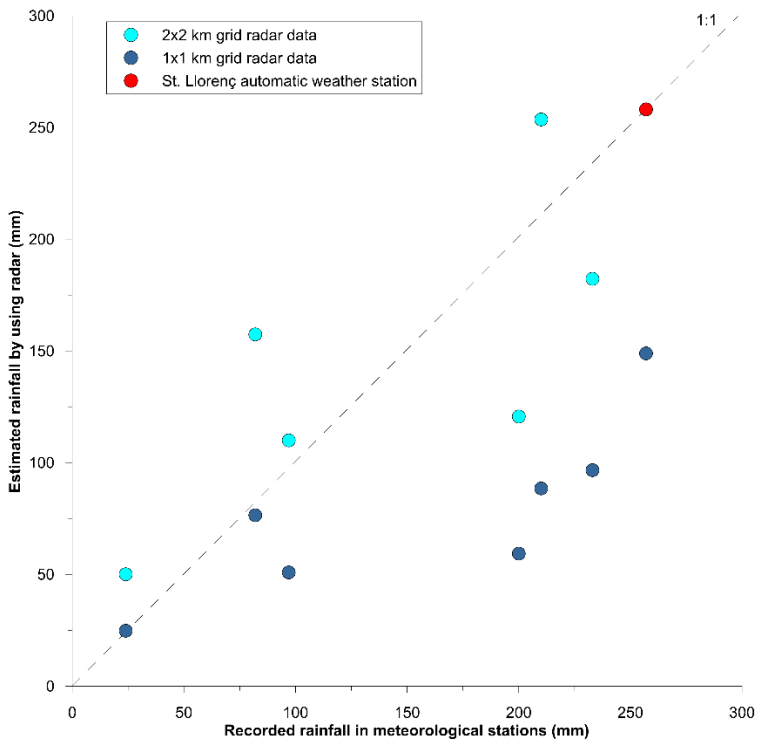
Figure S1 Scatterplot of recorded rainfall in meteorological stations and estimated rainfall by using different grid radar.

method to correct rainfall estimation based on spatial resampling is put forward here. Accordingly, the 2×2 km spatial resolution of radar data was resampled by assigning to each grid cell the value of the maximum amount of estimated rainfall at 1×1 km. By this method, the regression coefficient reached $R^2 = 0.8$, a percent bias of only $+2.6\%$ and 258 mm as the maximum estimated rainfall amount, which fitted the rainfall at that point (Fig. S1 in the Supplement).

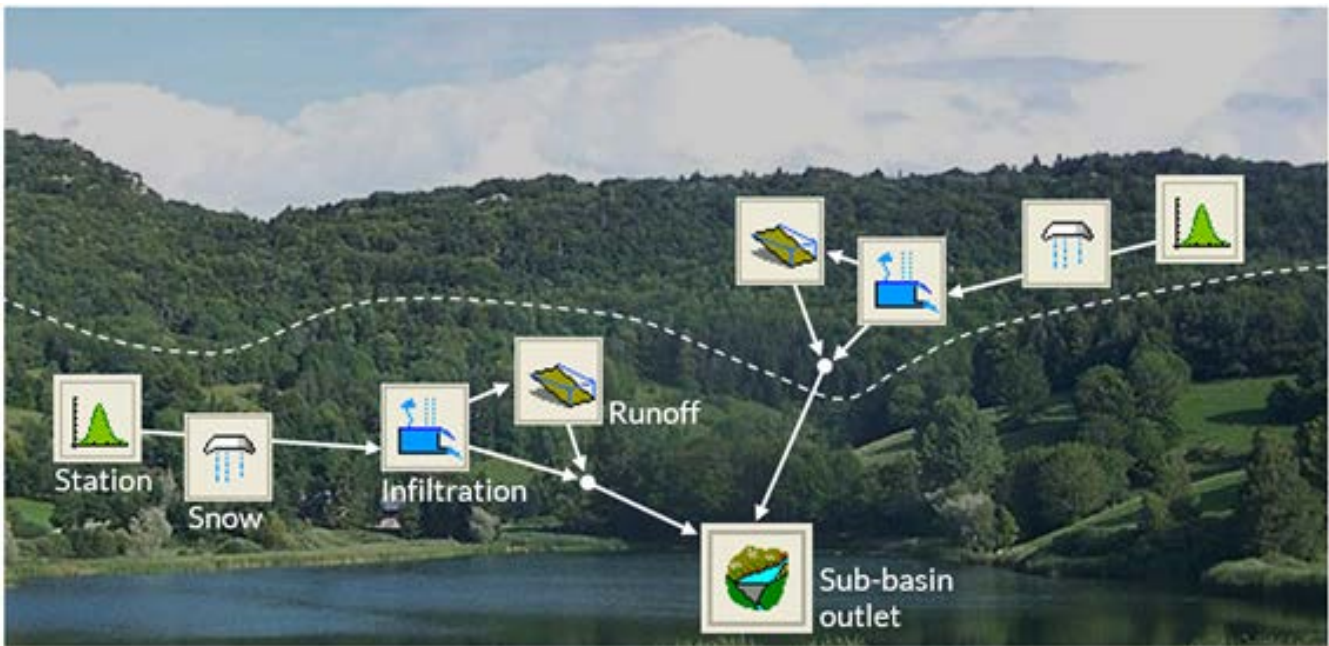
Figure S2 Semi-distributed rainfall-runoff modelling with GSM-SOCONT. The sub-basins is divided in two elevation bands in this example.

The SOCONT model is shown in Fig. S2. First, the temperature was interpolated for each elevation band, based on inverse distance weighting using the Shepard method (Shepard, 1968). Resampled 1 km resolution radar data (see Sect. 2.3) were used in the model to obtain precipitation for each elevation band by including all 1 km resolution points falling within each elevation band. The soil-infiltration model was based on modified GR3 equations (Schaeffli et al., 2005). Infiltration and evaporation were determined by the soil saturation; i.e. infiltration is higher for lower soil saturation, whereas evapotranspiration is higher for high soil saturation.

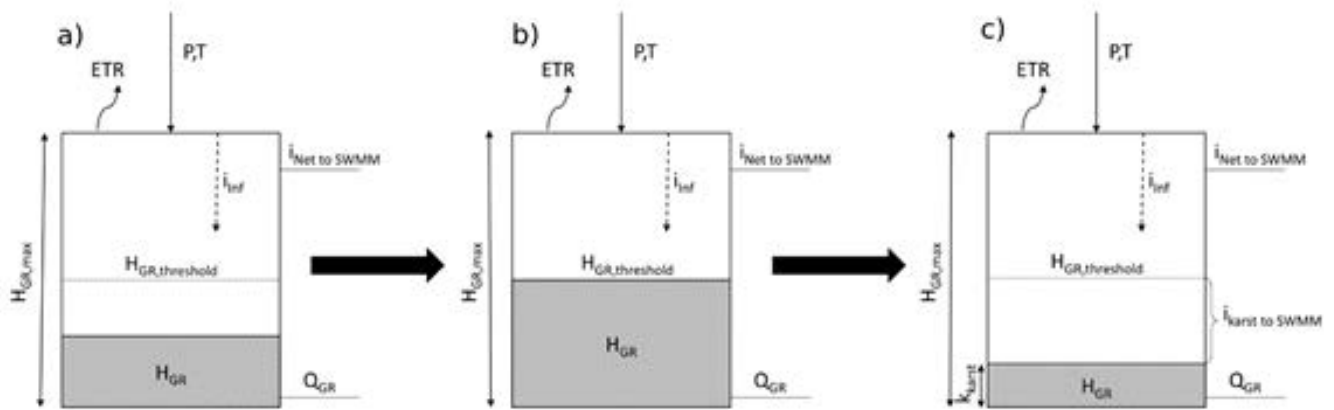
Figure S3 Scheme of the modified infiltration model including a karstic component. Only the relevant parameters are shown, being Q_{GR} : outflow from the infiltration reservoir; H_{GR} : level in infiltration reservoir (State variable); $H_{GR,threshold}$: height of the onset of karstic behaviour; $H_{GR,max}$: Maximum height of infiltration reservoir i_{karst} : karstic release coefficient; ETR : Evapotranspiration; i_{inf} : Infiltration intensity; $i_{Net\ to\ SWMM}$: surface runoff intensity; P,T : Precipitation, Temperature

Surface runoff was computed with the Storm Water Management Model (SWMM). Soil infiltration was modified to simulate karstic hydrological dynamics, as shown in Fig. S3. Precipitation infiltrated the soil, as in Schaefli et al. (2005), as a function of soil saturation (Fig. S3a). The resulting outflow from the reservoir (Q_{GR}) is also dependent on the soil saturation: outflow increases with higher soil saturation. In the modified equations, soil saturation can increase up to a certain level ($H_{GR,threshold}$), with this being a parameter to be adjusted in the model (Fig. S3b). When this threshold is reached, the soil reservoir releases all the available volume contained between the $H_{GR,threshold}$ and the minimum water level (k_{karst} in Fig. S3c). The released volume of water is then transferred to the SWMM model described in Schaefli et al. (2005). The relevant parameters for the modified version of the soil infiltration model were the maximum soil capacity ($H_{GR,max}$), the threshold for the karstic behaviour ($H_{GR,threshold}$) and the release coefficient (k_{karst}).
