**Part 6:**

**Flood Hazards, GIS Applications and Flood Risk  
Management**

## 49. FLOODING VULNERABILITY OF A TOWN IN THE TANARO BASIN: THE CASE OF CEVA (PIEDMONT - NORTHWEST ITALY)

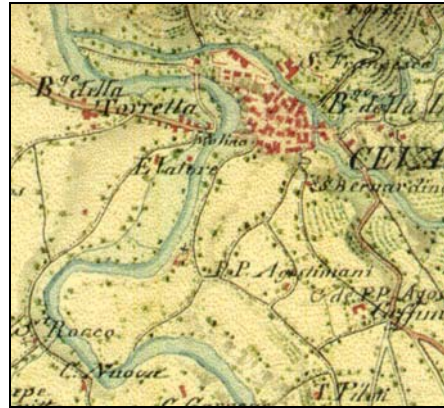
**Figure 2** – “Gran Carta degli Stati Sardi in Terraferma” mapped in 1818-19. In spite of the scale at 1:50.000, the village is clearly visible: the core of the village is “packed” between Tanaro River and Cevetta Stream. In the south there is only a large agricultural area.

The earliest map taken into account is the "Gran Carta degli Stati Sardi in Terraferma" (1819): in this map (Figure 2) the village is centred around the castle and the cathedral, that are located about 30 m higher than the surrounding area: the village is concentrated between Cevetta and Tanaro riverbeds and only a few houses are exposed to the floodings of the watercourses. The two banks are connected by the Cattalana bridge, already at that time made by the spans that exist today. In the southern zone, the large depression included between the village and the wide Tanaro bend is completely lacking in buildings.

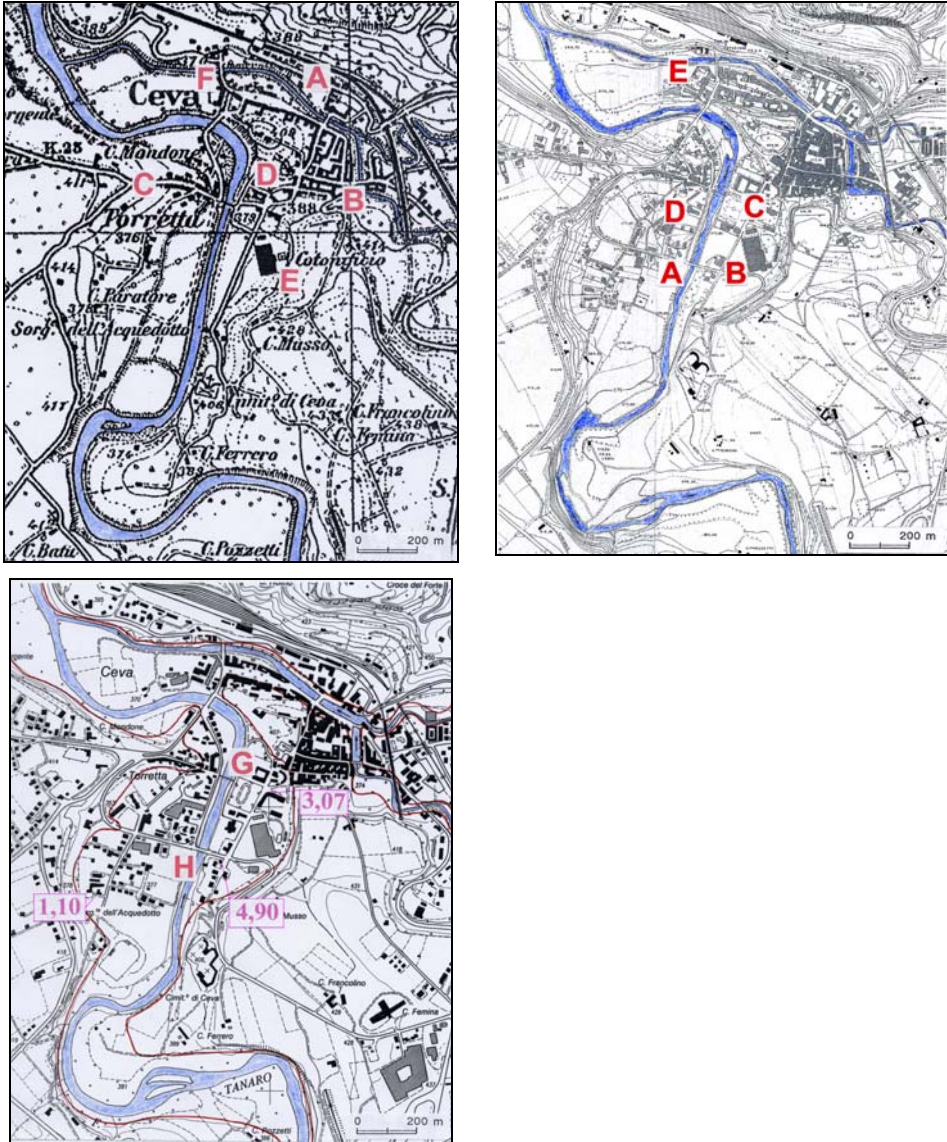
**Figure 3.** (top left) – Third edition of the Istituto Geografico Militare map, dated 1930. It shows how the urban centre grew in all directions and particularly to the North of the old centre, along the Cevetta Torrent, to the West (C), and to the South (E). All these areas were heavily damaged by the 1886 and 1926 events. **Figure 4.** (top right) – After the second World War there was a large urbanization. The 1971 map shows the urban expansion with the new buildings along the Tanaro riverbed (A-B-C-D), the same buildings that were heavily flooded in the November 1994 event. **Figure 5.** (bottom left) – November 5, 1994 map: the red line shows the largest extent of the Tanaro flooding. The water heights above the ground level, taken from the marks on the buildings (asterisks), are indicated in meters.

After more than one century, the 1930 map (Figure 3) shows great substantial modifications. In particular we can note the presence of the railway with the railway station (black lines) on the right Cevetta bank. In the same area there are two new bridges on the Cevetta and some new buildings on the right Cevetta bank (A), in the suburb of the old center (B), but above all on the left of the Tanaro (C, "Porretta" quarter) and on the south with a new area consisting of barrack (D), kindergarten (D), the spinning and water mills, schools, restaurant and a large industrial shed ("Cotonificio", E). Records show that on 1843 and 1885 the Tanaro inundated the area of the barrack, while on 1857 and 1876 the Cevetta flooded the A zone and some buildings in zone B ("Borgo Doria" quarter). But the heaviest inundation of XIX century occurred on November 10-11<sup>th</sup>, 1886. The Tanaro rose fast: waterfloods ran over the barracks square, the kindergarten, the spinning mill and the water mill, uprooting many trees, demolishing walls and carrying out everything. In the kindergarten a depth of 1-1.5 m was measured.

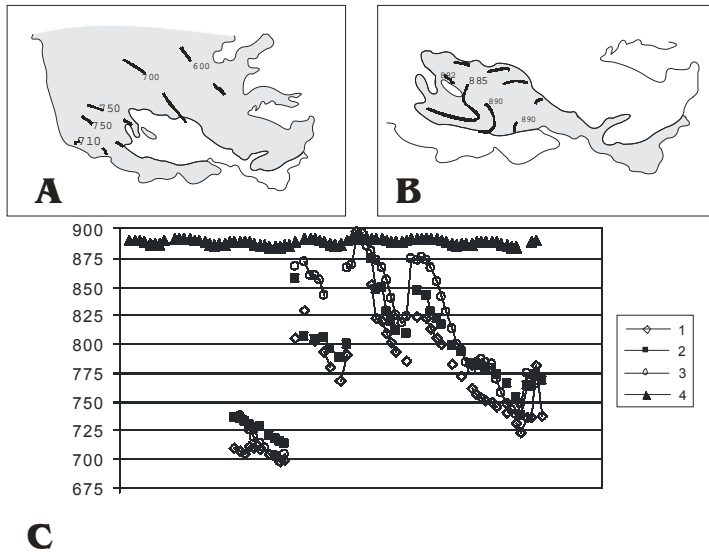
**Figure 2.** (A) Water table map of the Sierra Gorda karst aquifer adjacent to the polje, November 1989. (B) Water table map of alluvial aquifer, July 1982. (C) Water table evolution at three wells in the karst aquifer (1, 2 and 3) and one well in the alluvial aquifer (4).

Figure 2C shows the rise of more than 150 m at points 1, 2 and 3 at the end of 1995. This was, in fact, an extreme situation as it occurred during a shift from a very dry period to a very wet one and the change in level was therefore very high. About 75 to 100 m can be taken as normal variations between dry and wet seasons. The water table of the alluvial aquifer (line 4 of Figure 2C) is near the surface and seasonal variations are much less

pronounced (less than 10 m) than those of the karst aquifer. The two aquifers have different water tables (Figure 2A-2B) and so we can speak of two independent systems. However, there is normally supply from the detrital to the karst aquifer across the contact zones between permeable detrital rocks and the limestones of the Sierra Gorda aquifer, depending on a higher hydraulic head in the detrital aquifer. This flow can invert, with discharge from the karst aquifer to the detrital if the hydraulic head is higher in the former, which is what tends to occur during large floods (Figure 2C).

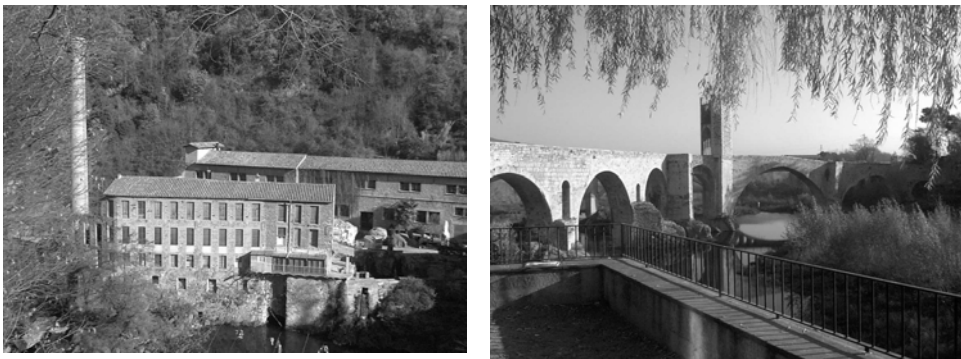
**Figure 1.** Some of the cultural elements studied: Textile mill of “can Porxes” (left), in the Banyà valley, and the romanesque bridge of Besalú.

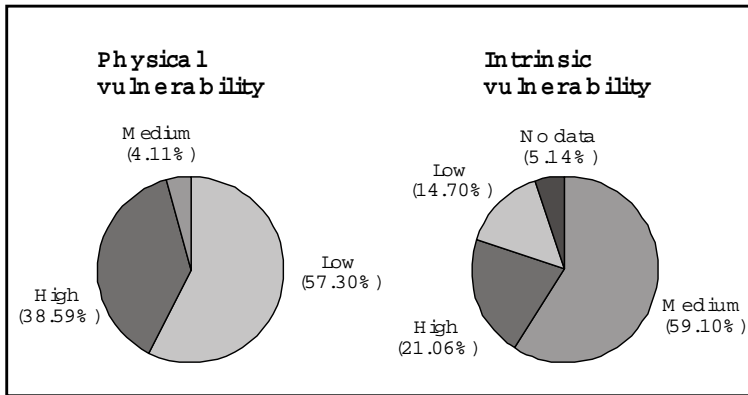
Figure 2. Distribution of physical and intrinsic vulnerabilities

With regard to intrinsic vulnerability, 230 elements belong to the class of “medium vulnerability” These are basically architectural elements, infrastructures in use or houses. The state of conservation is generally good and they have been the object of some restoration tasks. 82 elements have a high intrinsic vulnerability and 32 elements have a low intrinsic vulnerability. Data for intrinsic vulnerability is missing in the remaining cases.

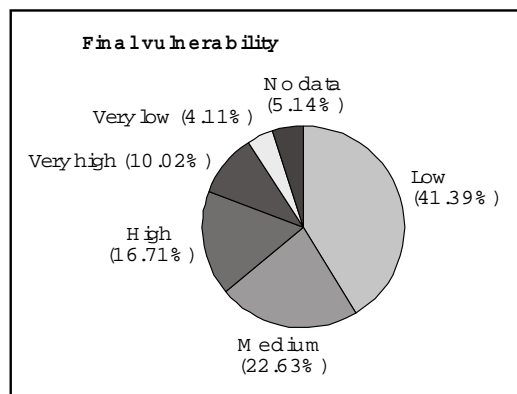
Figure 3. Distribution of final vulnerability

In terms of total vulnerability, most elements (161) belong to the low vulnerability class (41.39 percent). The next category in importance is the medium vulnerability class with 88 elements (22.63 percent) elements inventoried. Sixty five elements (16.71 percent) present a high final vulnerability; 39 (10.02 percent) a very high final vulnerability, 16 (4.11 percent) a very low final vulnerability, and for 20 elements we have no complete data.

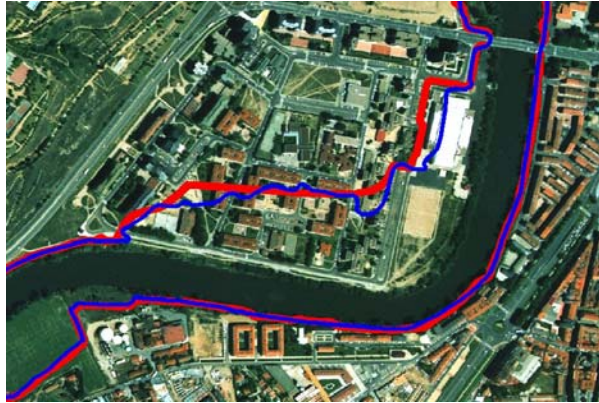
**Figure 5.** Ortho aerial photograph showing the flood outer limits (black line). The thicker grey line marks the limit of the 500 year flood estimated by the Confederación Hidrográfica del Duero.

The flooding surface for this event has been mapped on a high precision scale (1:2000) with the help of an an ortho rectificated aerial photograph (Figure 5).

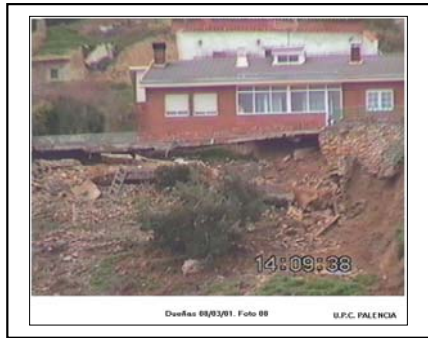
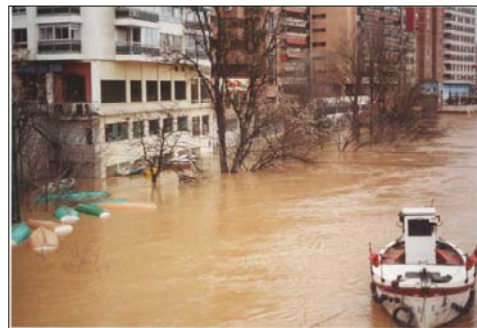
**Figure.6.** Landslide affecting a house foundation, during the March 2001 flood event (left). **Figure.7.** High water level affecting garages and basements in Valladolid (right).

Related damages were mainly reported on crops and lower flats within buildings (Figure 7), landslides associated effects (Figure 6) also being registered. Economical losses of more than 38 million euros were estimated, although no victims were reported on that occasion.
