ASSESSMENT AND EVALUATION OF THE REPAIR OPTIONS FOR THE TORROJA INSTITUTE WINTER GARDEN

O. Río & J Mateo
CSIC-UPM
CISDEM
Serrano Galvache, 4
28033-Madrid
Spain
rio@ietcc.csic.es

KEYWORDS: crack repairs, masonry shell, unreinforced brickwork, Torroja, FE analysis

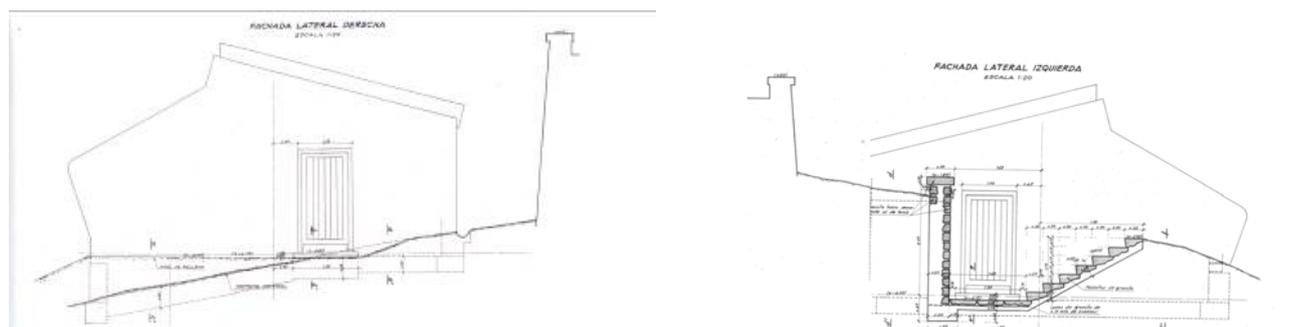
The winter garden building is situated close to the tennis court wall coping, over a sloped bed partially filled on the south-east (Figure 2 and 5). It is formed by a main space of six modules of 5.08 m x 7.05 m and two anterooms (Figure 2) of similar area. The whole area is covered by eight shallow barrel vaults leaning towards north and a glass structure leaning to the south. The main space forms an open-plan with planting beds along the longitudinal edge, only interrupted by the open arcades which act as support of

Figure 5: Level of earth between West and East façades of actual winter garden as it is shown in the original IETcc plans

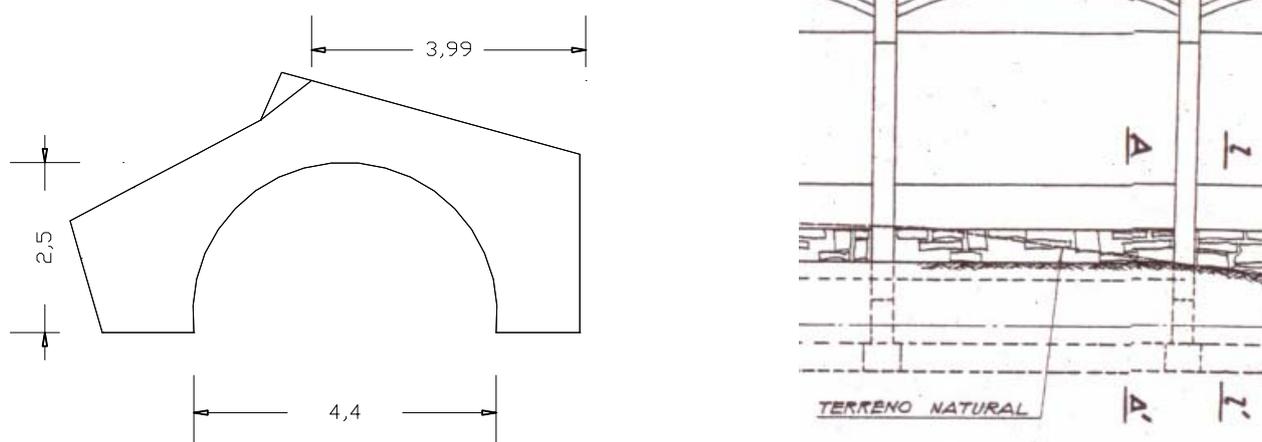
All the structural elements (vaults and arcades) as well as the walls were made of a single leaf of unreinforced brickwork, a quite exceptional application by Torroja (Antuña 1999, 2009), and then rendered with a trowel applied cement screed. Each arch has a parabolic profile, of a 4.4 m span and 2.5m rise (Fig. 6), springing from deep returns on the walls. The thickness of the arch and return is 0.25 m.

Figure 6. Aspect and geometry of the arches and cross section of the vaults

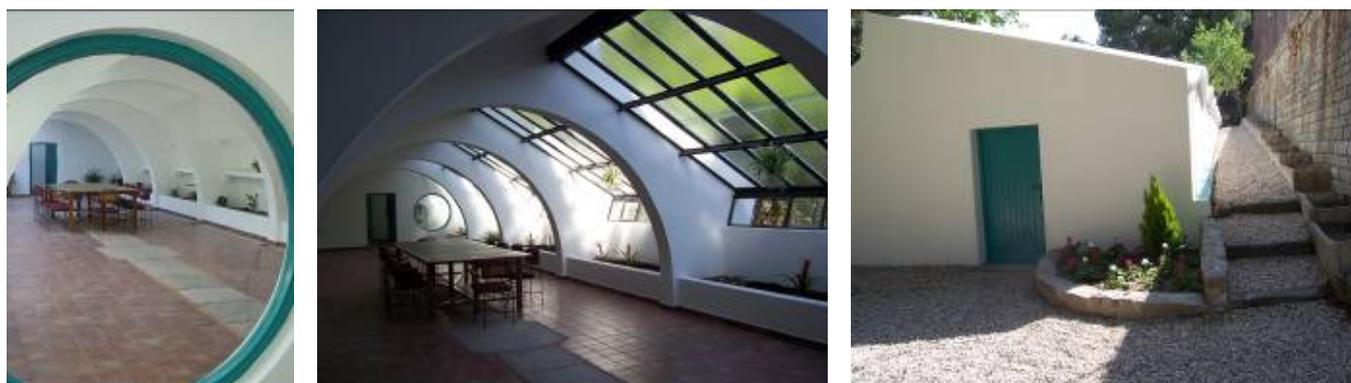
Figure 15: The winter garden at present

The surrounding areas were cleared from overgrowth and the planting bays close to the wall were removed, while all drainage was refurbished. Once the integrity of the structure was restored, thermal insulation and a waterproofing screed was applied on the vaults. In the interior, a new single-coat render was applied. So far as the metal frame of the windows is concerned, all the mullions were cleaned and the

glass panels that had not been damaged were placed once again. The damaged ones were replaced with reinforced glass that was distinct from the original panels and for this reason two entire bays were glazed this manner. In addition, the most damaged metal mullions were protected from the ingress of water. Eventually, the building at the end of the works is the very pleasant multi-functional space that was planned (Fig. 15).
