PROCEEDINGS OF THE FIRST INTERNATIONAL CONFERENCE ON RAMMED EARTH
CONSERVATION, RESTAPIA 2012, VALENCIA, SPAIN, 21–23 JUNE 2012

Rammed Earth Conservation

Restoration of the Andalusí wall of the Alcazaba Antigua (Ancient Citadel) of Granada (Cuesta de Alhacaba area)

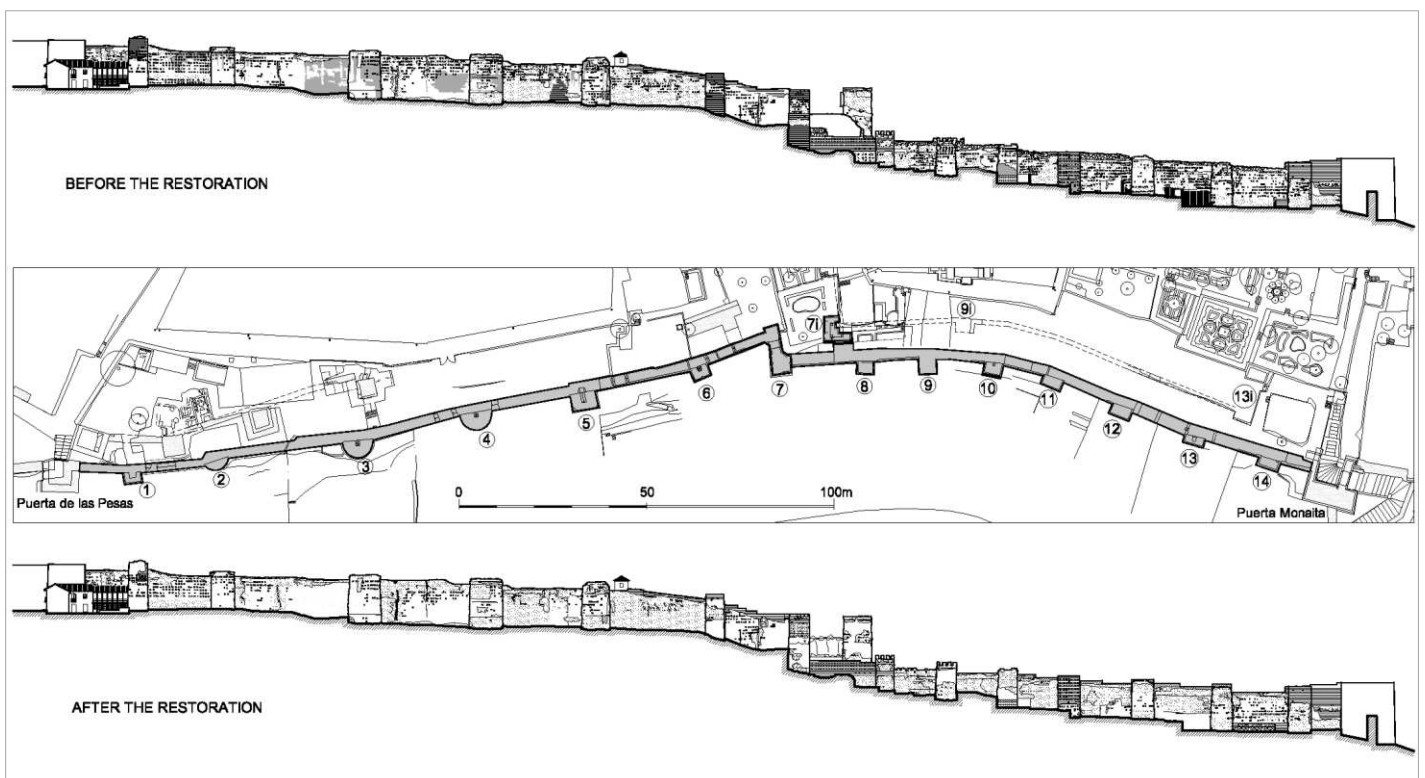
The stretch of wall subject to intervention is 350 m long, between Puerta del Ensanche or de las Pesas (*Bab al-Ziyada*) and Puerta Monaita (*Bab al-Unaydar*), with fourteen intermediate towers, and it can be divided into two areas (Fig. 2). In the centre of the eastern one, beginning in the first aforementioned door, there are three semi-cylindrical towers and another prismatic one, all of a large size and considerably separated. When we reach tower 7, which was initially built as an *albarrana* (a flanking tower linked to the wall by a brick vault), there is a turn in direction and a break in the parapet walk, and the 150 m of the western area runs on to a plateau at a lower level than the previous one. The seven towers of this sector have a rectangular layout, are fairly near each other and stand out only a little from the wall. Towers 8 and 9 and the panel between them have maintained the parapet and the crenellation, with two loopholes carved in the parapet. The average height of these stretches is about 10 m, and reaches a height of 15 m in some towers; the width varies between 2.70 – 3.60 m. The towers stand out

Figure 2. Plan and elevations before and after the restoration.

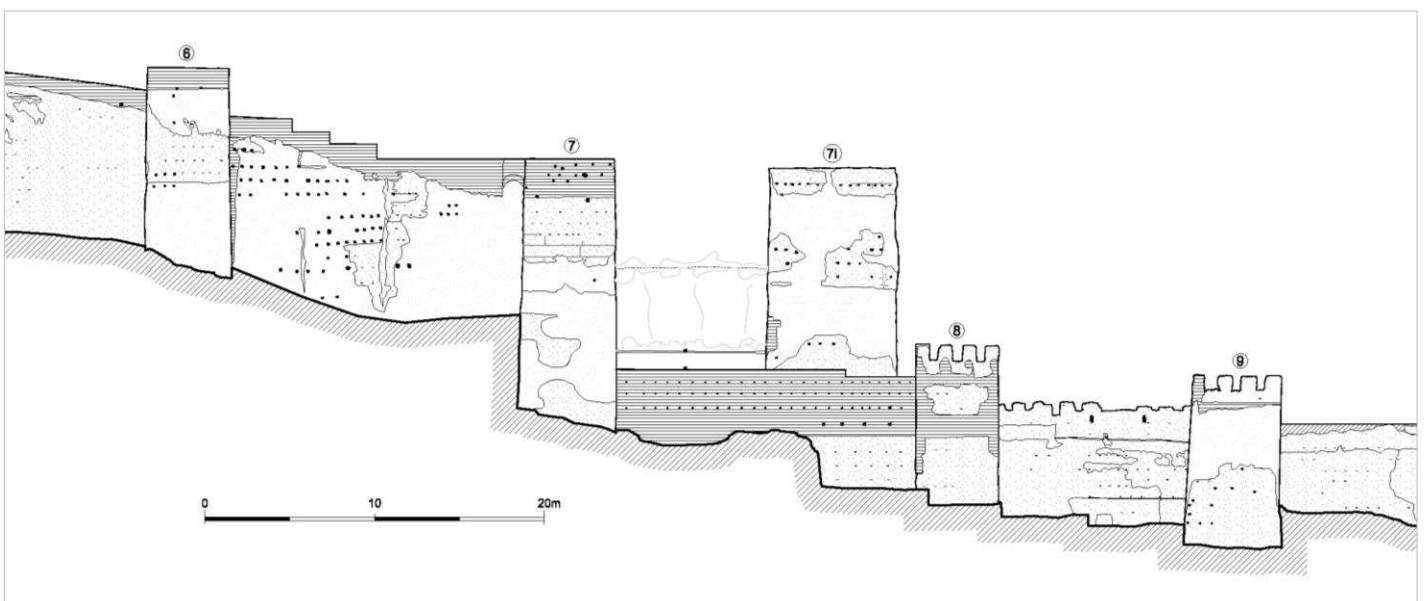
Figure 3. Elevation of the central section after the restoration.

All the accessible wall faces of towers and panels were restored as well as their upper parts so the conditions for draining away rainwater were improved. No work was done on the intramural wall face situated between the Puerta de las Pesas and tower 5, which had undergone intense restoration in the 1980s.
