On the Delamination of FeCrAl ODS Alloys

Abstract

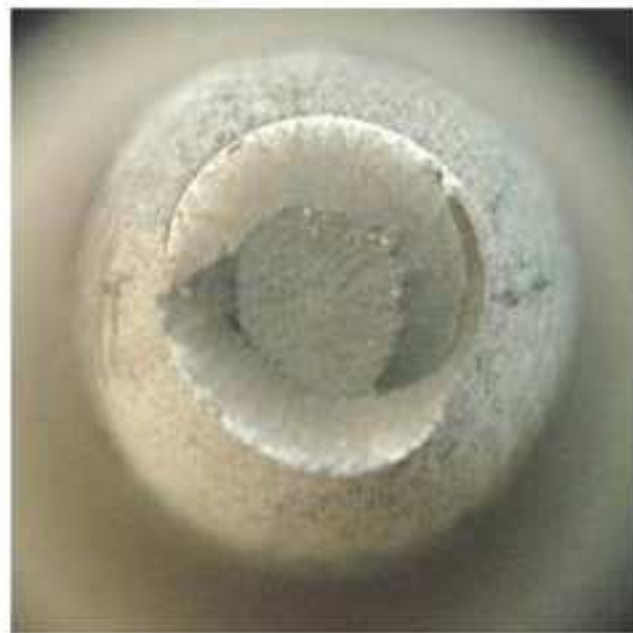
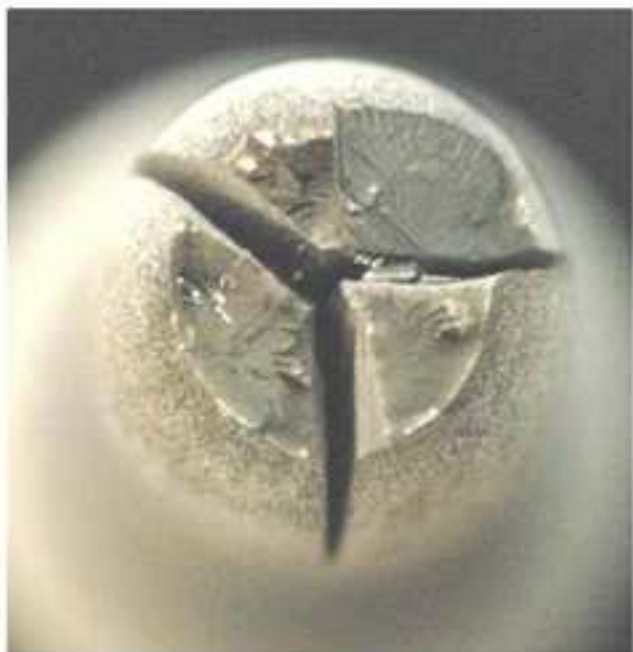
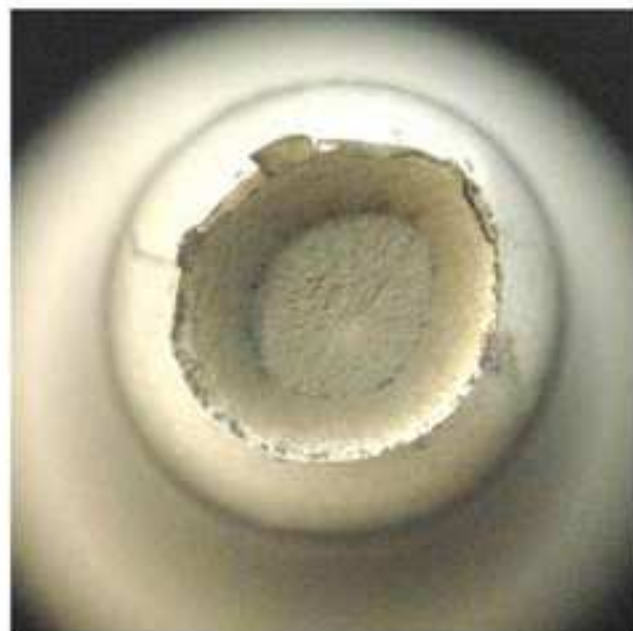
Figure 3. SEM macrographs showing the necking features of tensile specimens of PM2000 alloy. a) As-received condition $\dot{\epsilon}=5.10^{-5}s^{-1}$. b) As-received condition $\dot{\epsilon}=5.10^{-2}s^{-1}$. c) Aged condition $\dot{\epsilon}=5.10^{-5}s^{-1}$. d) Aged condition $\dot{\epsilon}=5.10^{-2}s^{-1}$

Figure 3 shows the macroscopic appearance of fracture surfaces of longitudinal tensile specimens, revealing a strong area reduction, which are consistent with the large elongation values given in Table II. In the case of the specimens tested at the highest strain rate, Figs. 3.b and 3.d the shape of the necking presents a slight asymmetry. The specimens tested in the lowest strain rate, Figs. 3.a and 3.c, present delamination.

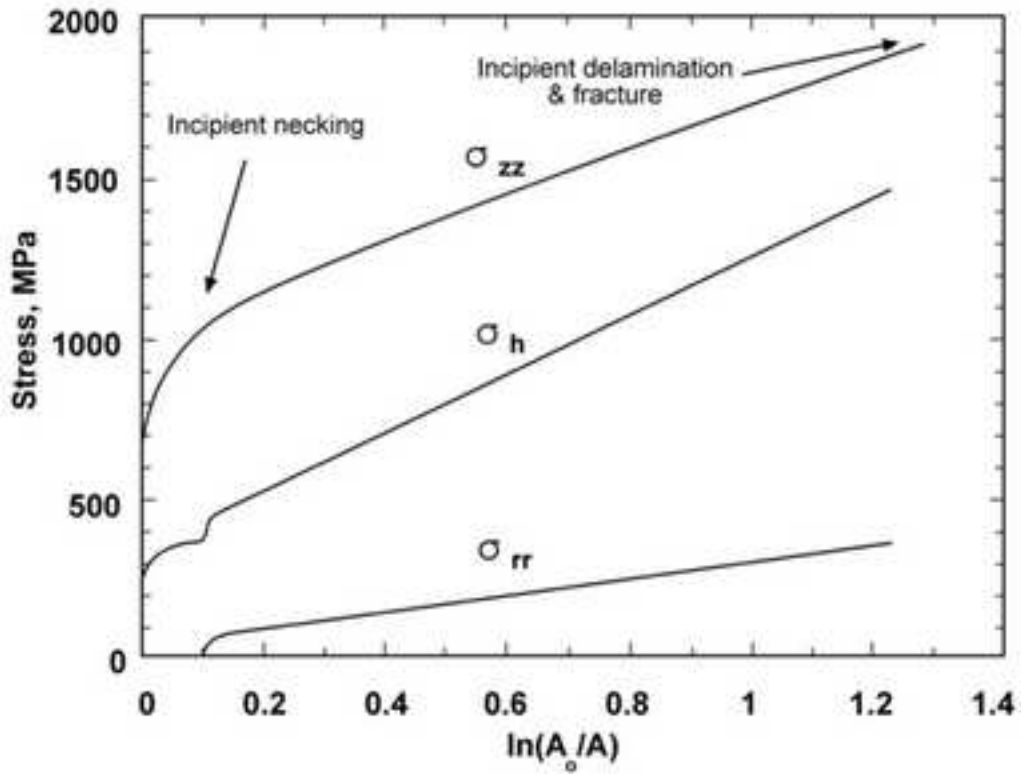
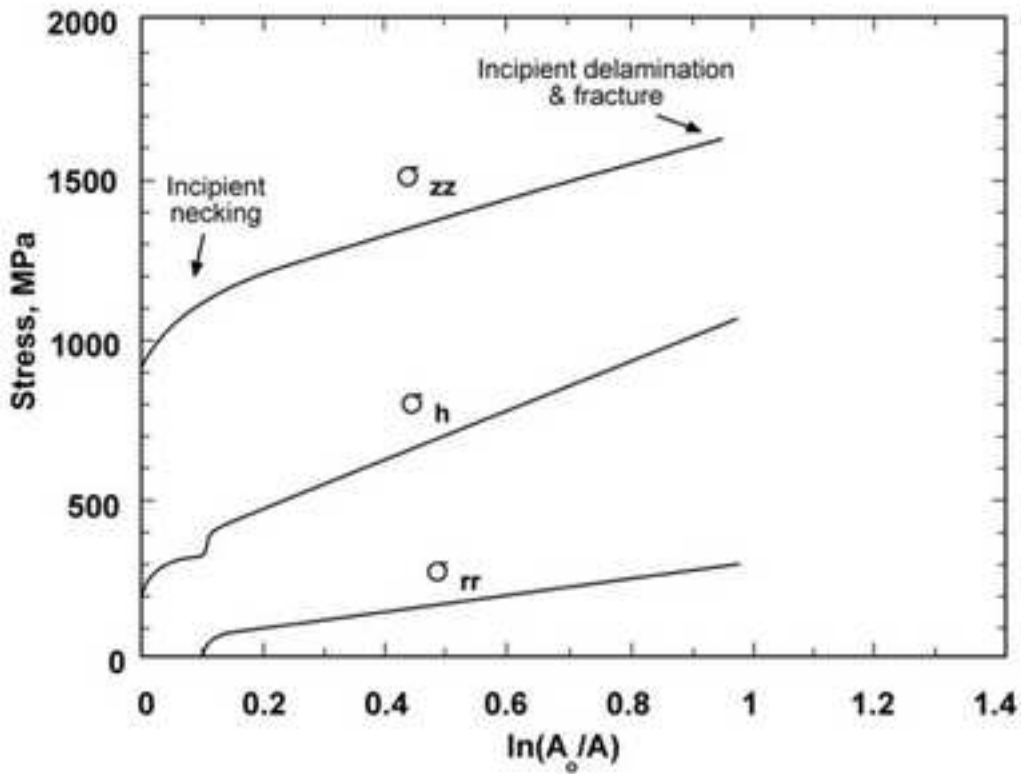
Figure 4. Evolution in longitudinal specimens of PM 2000 alloy of the average axial (σ_{zz}) stress, the radial (σ_{rr}) stress, and the hydrostatic (σ_h) stress components at $z=r=0$ during deformation and necking. $z=0$ is the location of minimum cross section of necking and $r=0$ is the axis of tensile specimen. A_0 and A are the initial and actual cross section areas of specimen during tensile test. $\dot{\epsilon}=5.10^{-5}s^{-1}$ a) As-received condition. b) Aged condition

Figure 4 shows for the lowest strain rate the influence of aging treatment on the true stress vs true strain plot and the instant in which necking and delamination events were initiated. In order to detect the beginning of the delamination various tensile specimens were strained at the lowest strain rate very near to the fracture stress and then unloaded. Cross sectional views were prepared by sectioning parallel to the longitudinal axis of specimen. It was not observed evidence of incipient delamination, or transverse cracking at the centre of the necked cross section. It was only observed nucleation of isolated voids in the largest oxide particles in the necked region. The calculated maximum values of radial (σ_{rr}) and hydrostatic (σ_h) stress components at the minimum cross section versus true strain are also plotted in Fig. 4, to evaluate the possibility of a delamination process necking-induced. These values were calculated in accord with the Bridgman's analysis [35] from the actual values of the flow stress ($\bar{\sigma}$) and the necking profile using the following expressions:
