Drone analysis of medieval fortifications: the district of Loja in the Nasrid kingdom of Granada (Spain)

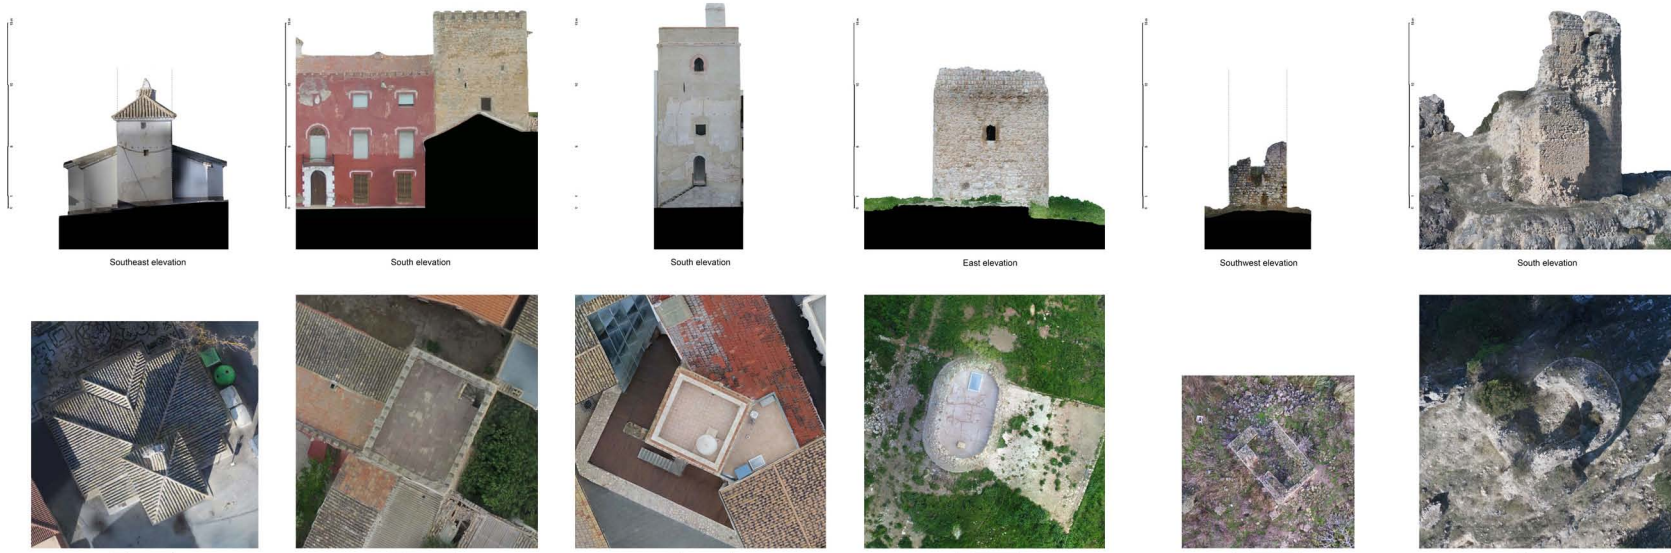
Fig. 4 - Comparison among the farmstead towers documented in Loja.

which have endured in form of a neighborhood, a farmhouse or as fully formed municipalities— a tower has been preserved (Fig. 4). It was the most visible and predominant element of defensive enclosures that often also had walled spaces to protect people, animals, and movable property (Martín García, 2010: 48-54).

Among these items we can highlight the Tower of the Frontil, the Tower of Salar or Pulgar's Tower, the Tower of Agicampe, the Tower of Abor or Campo Agro, the Tower of Huétor, and the Farmhouse of the Towers or Tájara Castle (Fig. 4).

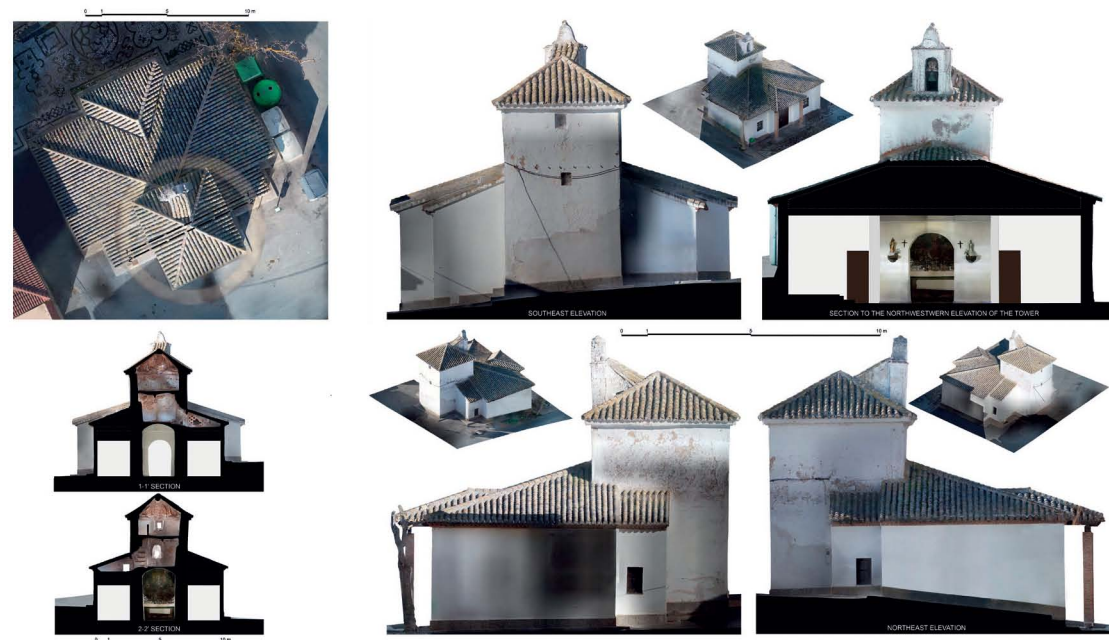
Fig. 7 - Graphical documentation of the Frontil Tower. Its remains are included in the bell tower of the Chapel of Nuestra Señora de la Esperanza (Loja).

Initially, a detailed sketch of the interior of these two floors and of the spaces of the chapel was made, as well as a complete taking of measurements, following the basic principles of architectural surveying, such as triangulation or measurement of distances correlative to an origin. At the same time, a process of photographic documentation was carried out at the ground level of all these spaces, together with a drone shot of the entire exterior volume of the chapel. This photographic work made it possible to develop a complete photogrammetric model that was referenced with data obtained with a total station (Fig. 7).
