Review

Biodiversity of cyanobacteria and green algae on monuments in the Mediterranean Basin: an overview

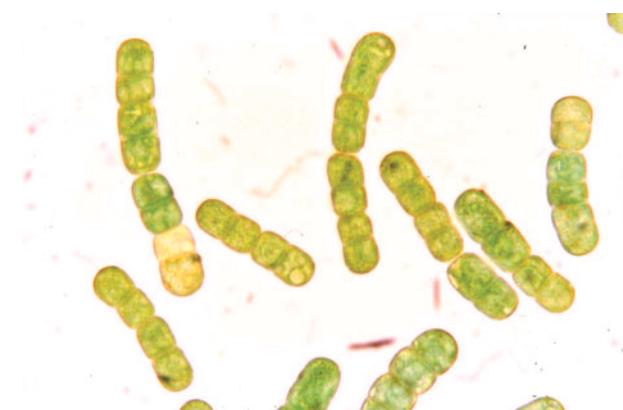
Fig. 6. Light micrograph of trichomes of *Borzia perikleii*, composed of 4–8 cells. Cells are 5–6 μ m wide and 5–11 μ m long.
